CORAL REEF REHABILITATION PROJECT

**Coastal and Marine Management Division
Protected Area, Wildlife and Coastal Zone Management Service
Department of Environment and Natural Resources
Region XI, Davao City**

PROJECT DESCRIPTION

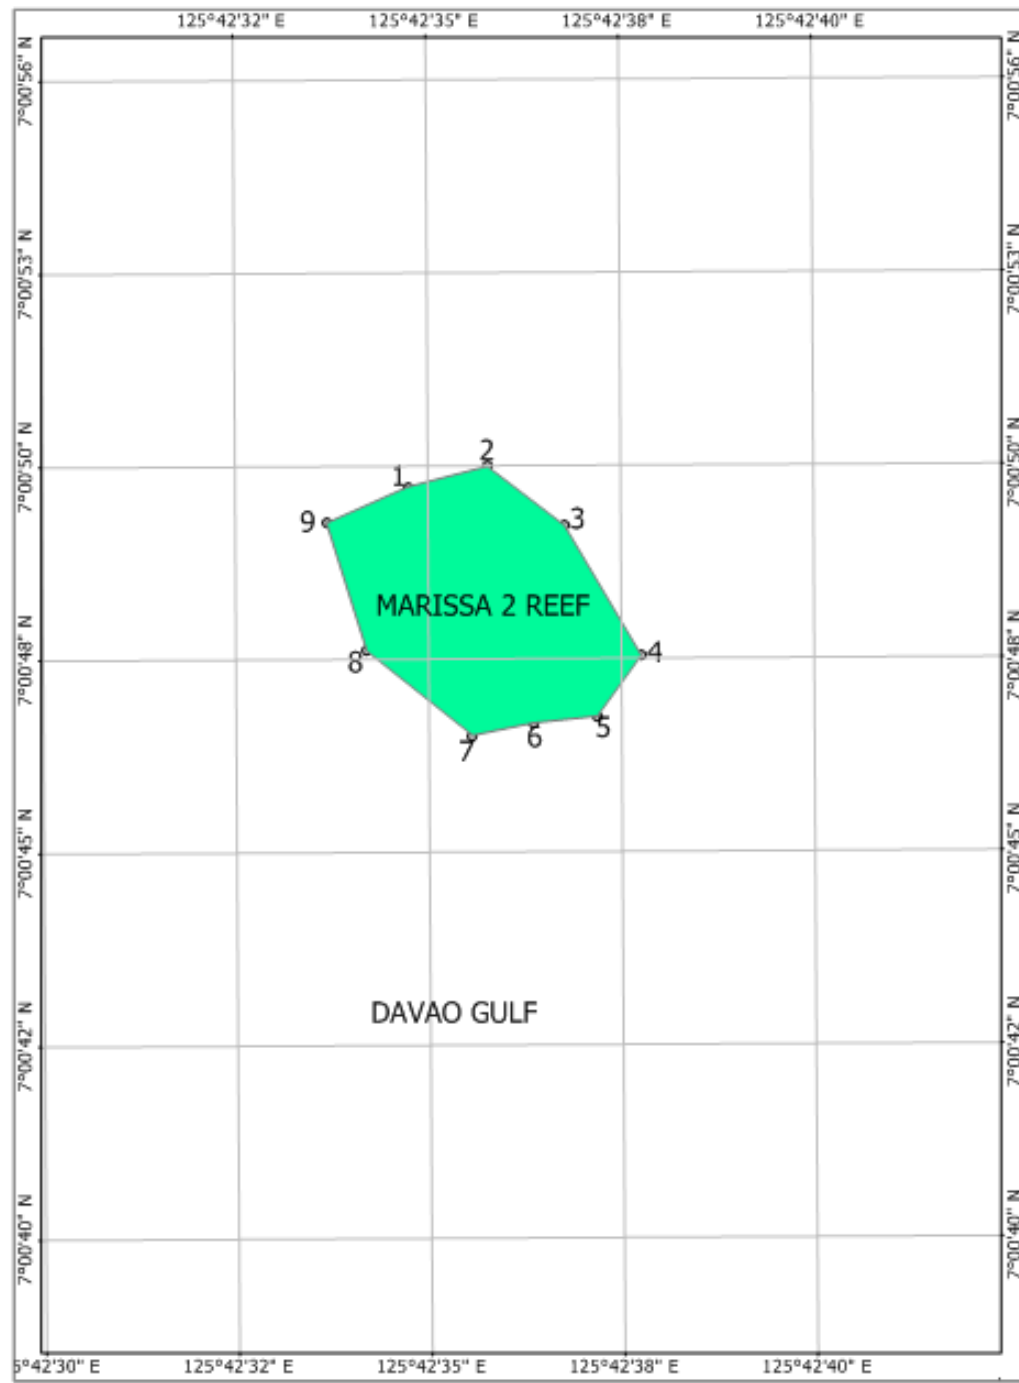
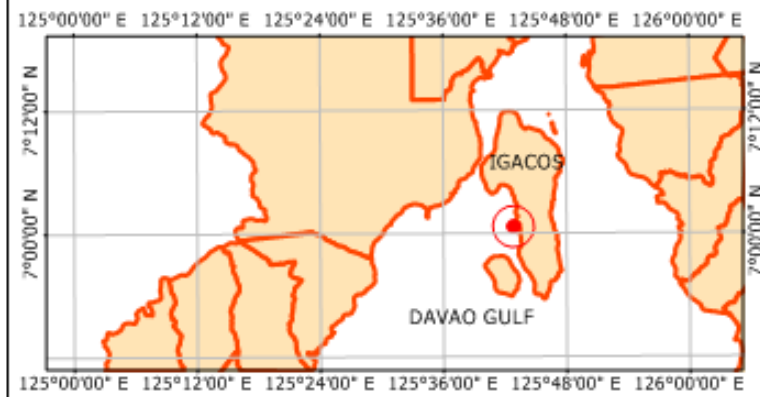
MAP SHOWING THE AREA OF MARISSA 2 REEF,
BRGY. ADECOR, KAPUTIAN DIST., IGACOS

- The reef area is located near the vanishing island of Jagnaya, Brgy. Adecor, Kaputian District, Island Garden City of Samal**
- Is a fishing ground for the local fisherfolks**
- Has patches of coral structures with wide spacing**
- Coral rubble and sand dominate the spaced area.**
- Depth range is about 8 - 43 ft.**
- Also observed to be prone to sandslide owing to its sloping topography.**

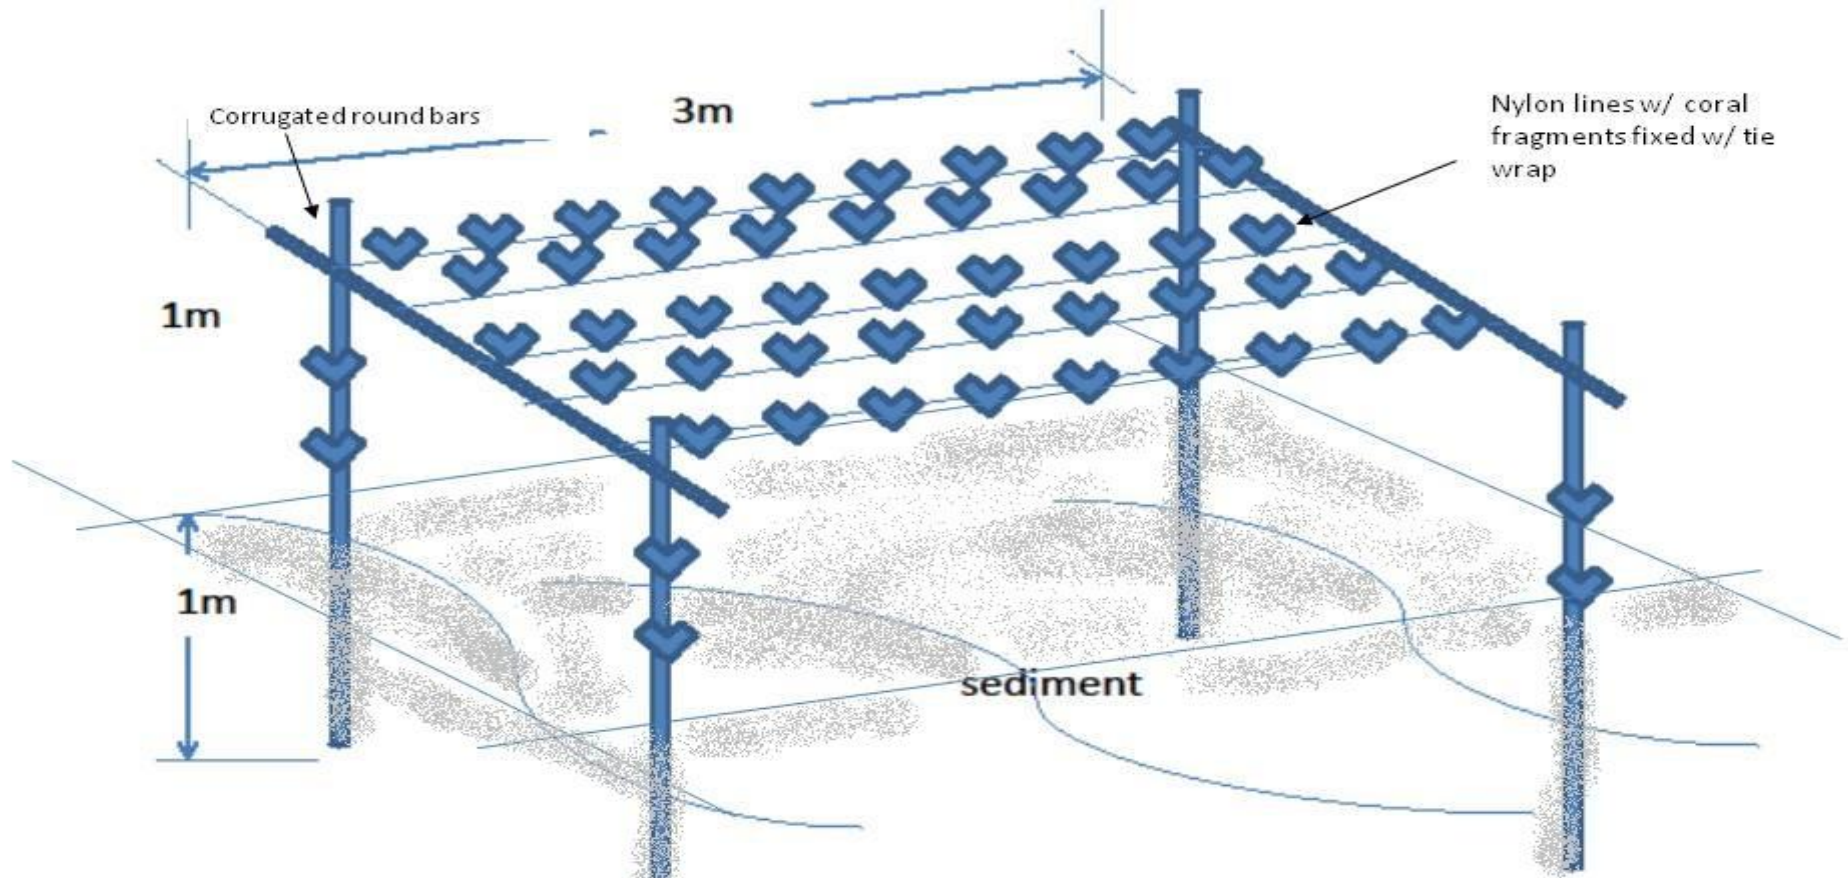
Module Design 1 : “Sampayan Sytle” - made up of two steel frames at both ends of the line; 5 nylon lines (3m long) to where the coral fragments were attached

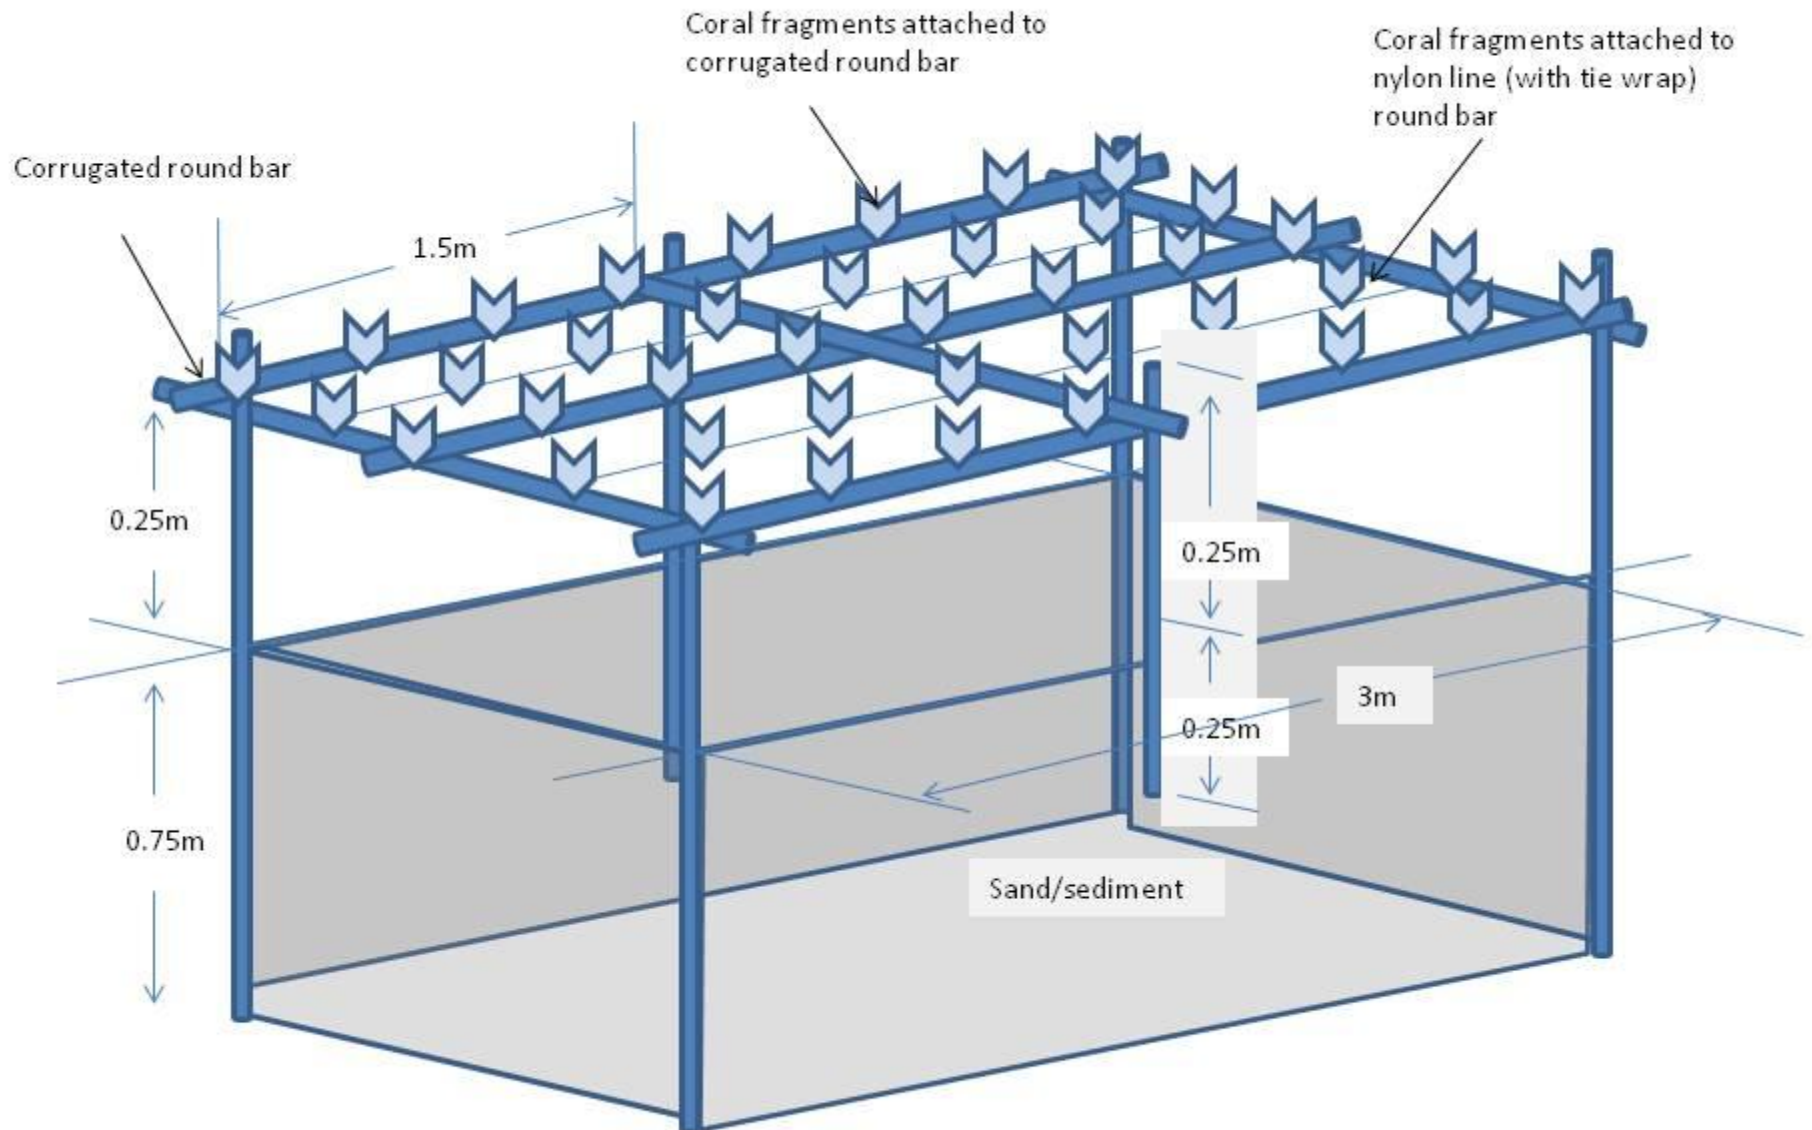
Module Design 2 : Modified steel frame with only 2 nylon lines and 3 steel bars to hold corals fragments

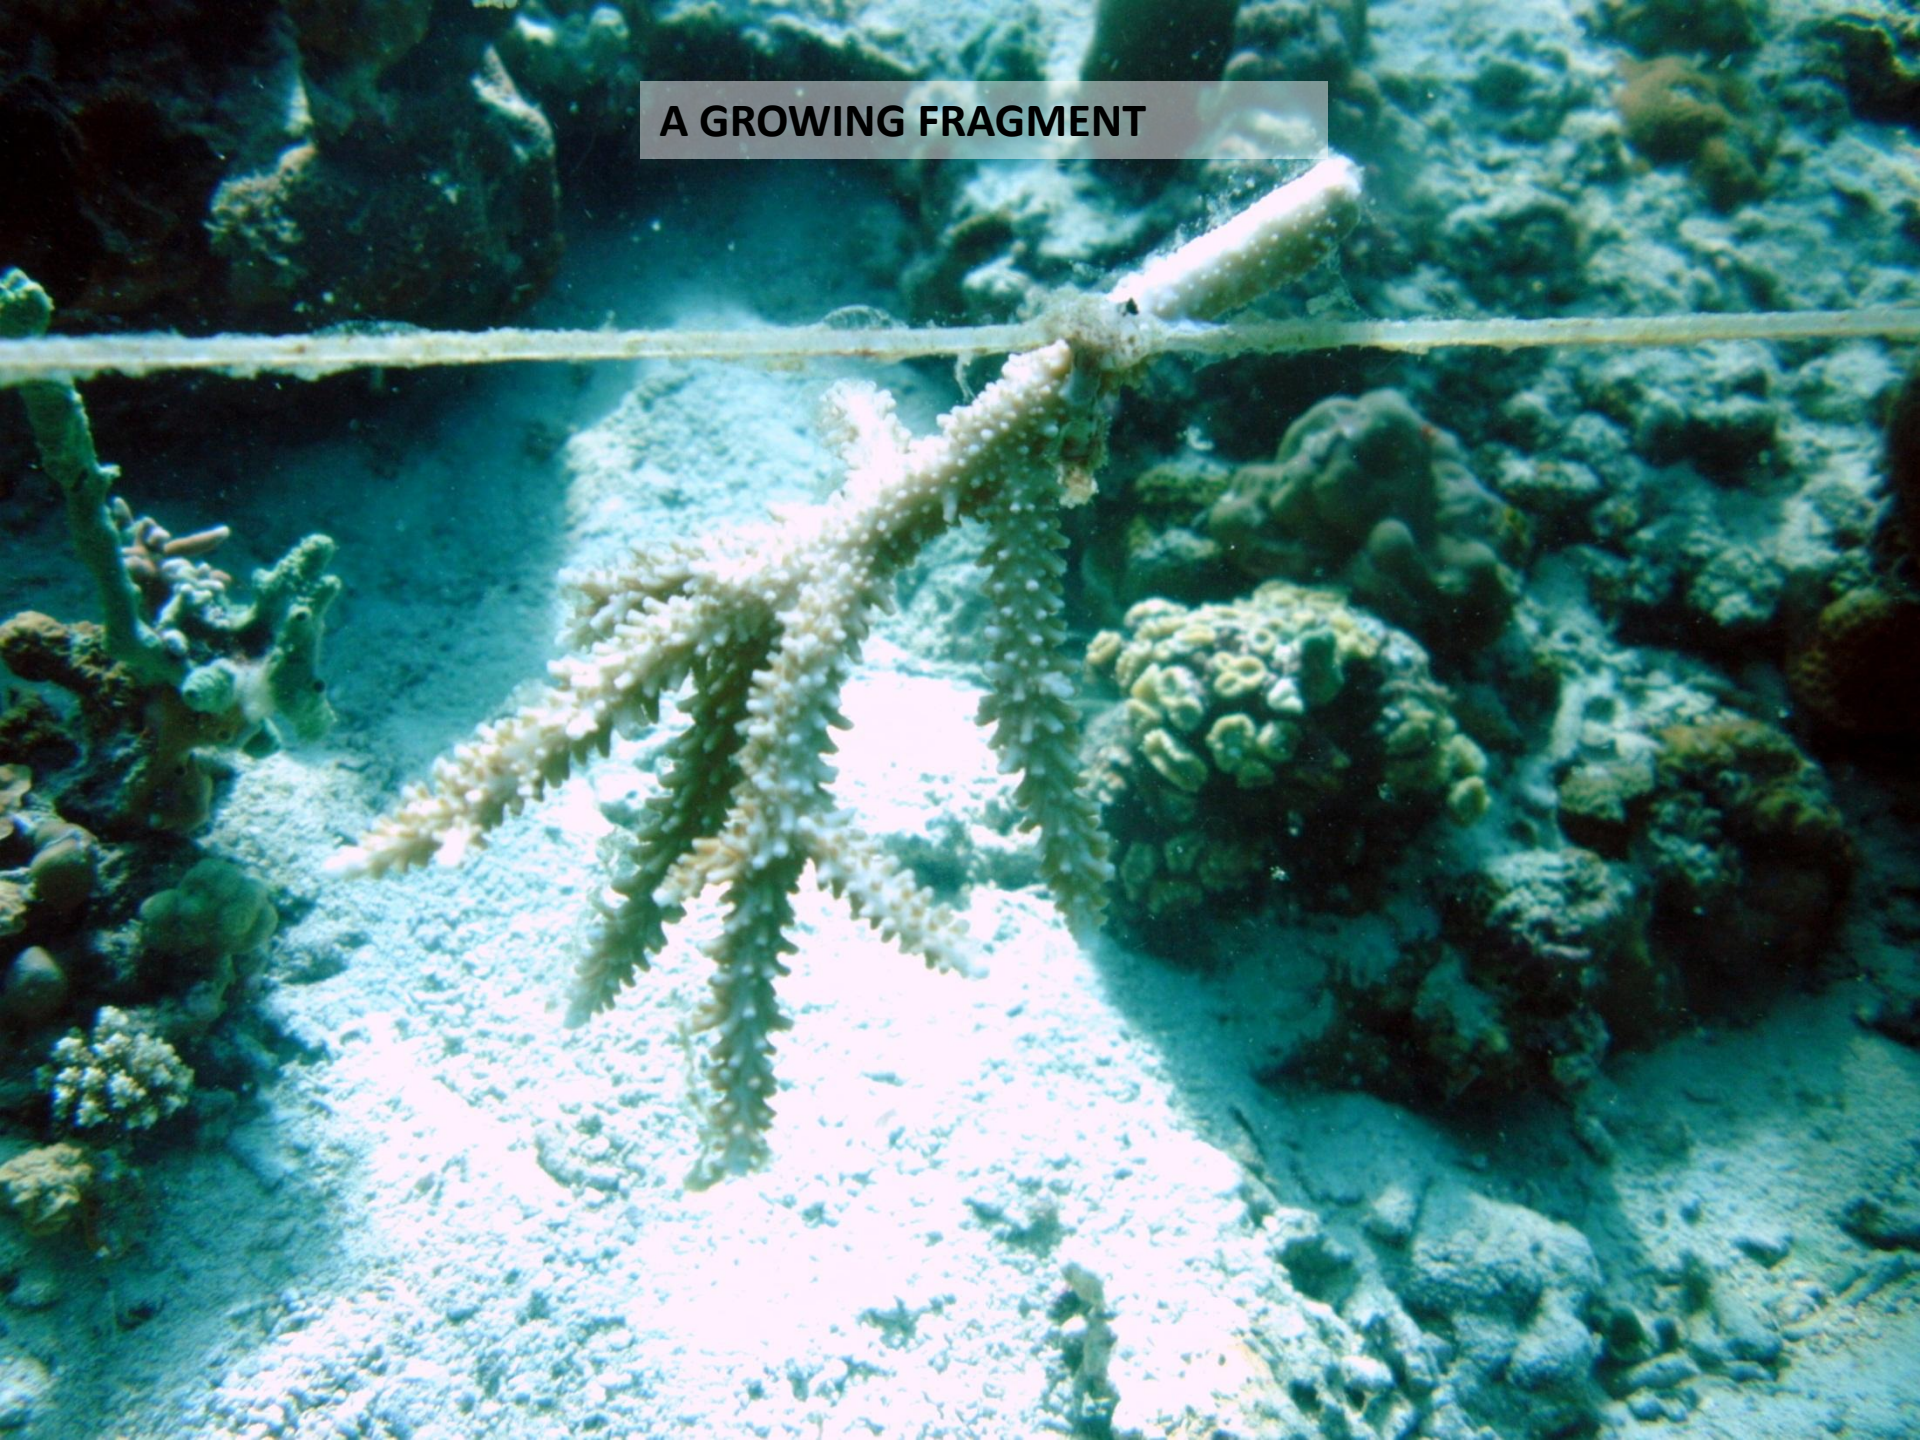
A GROWING FRAGMENT

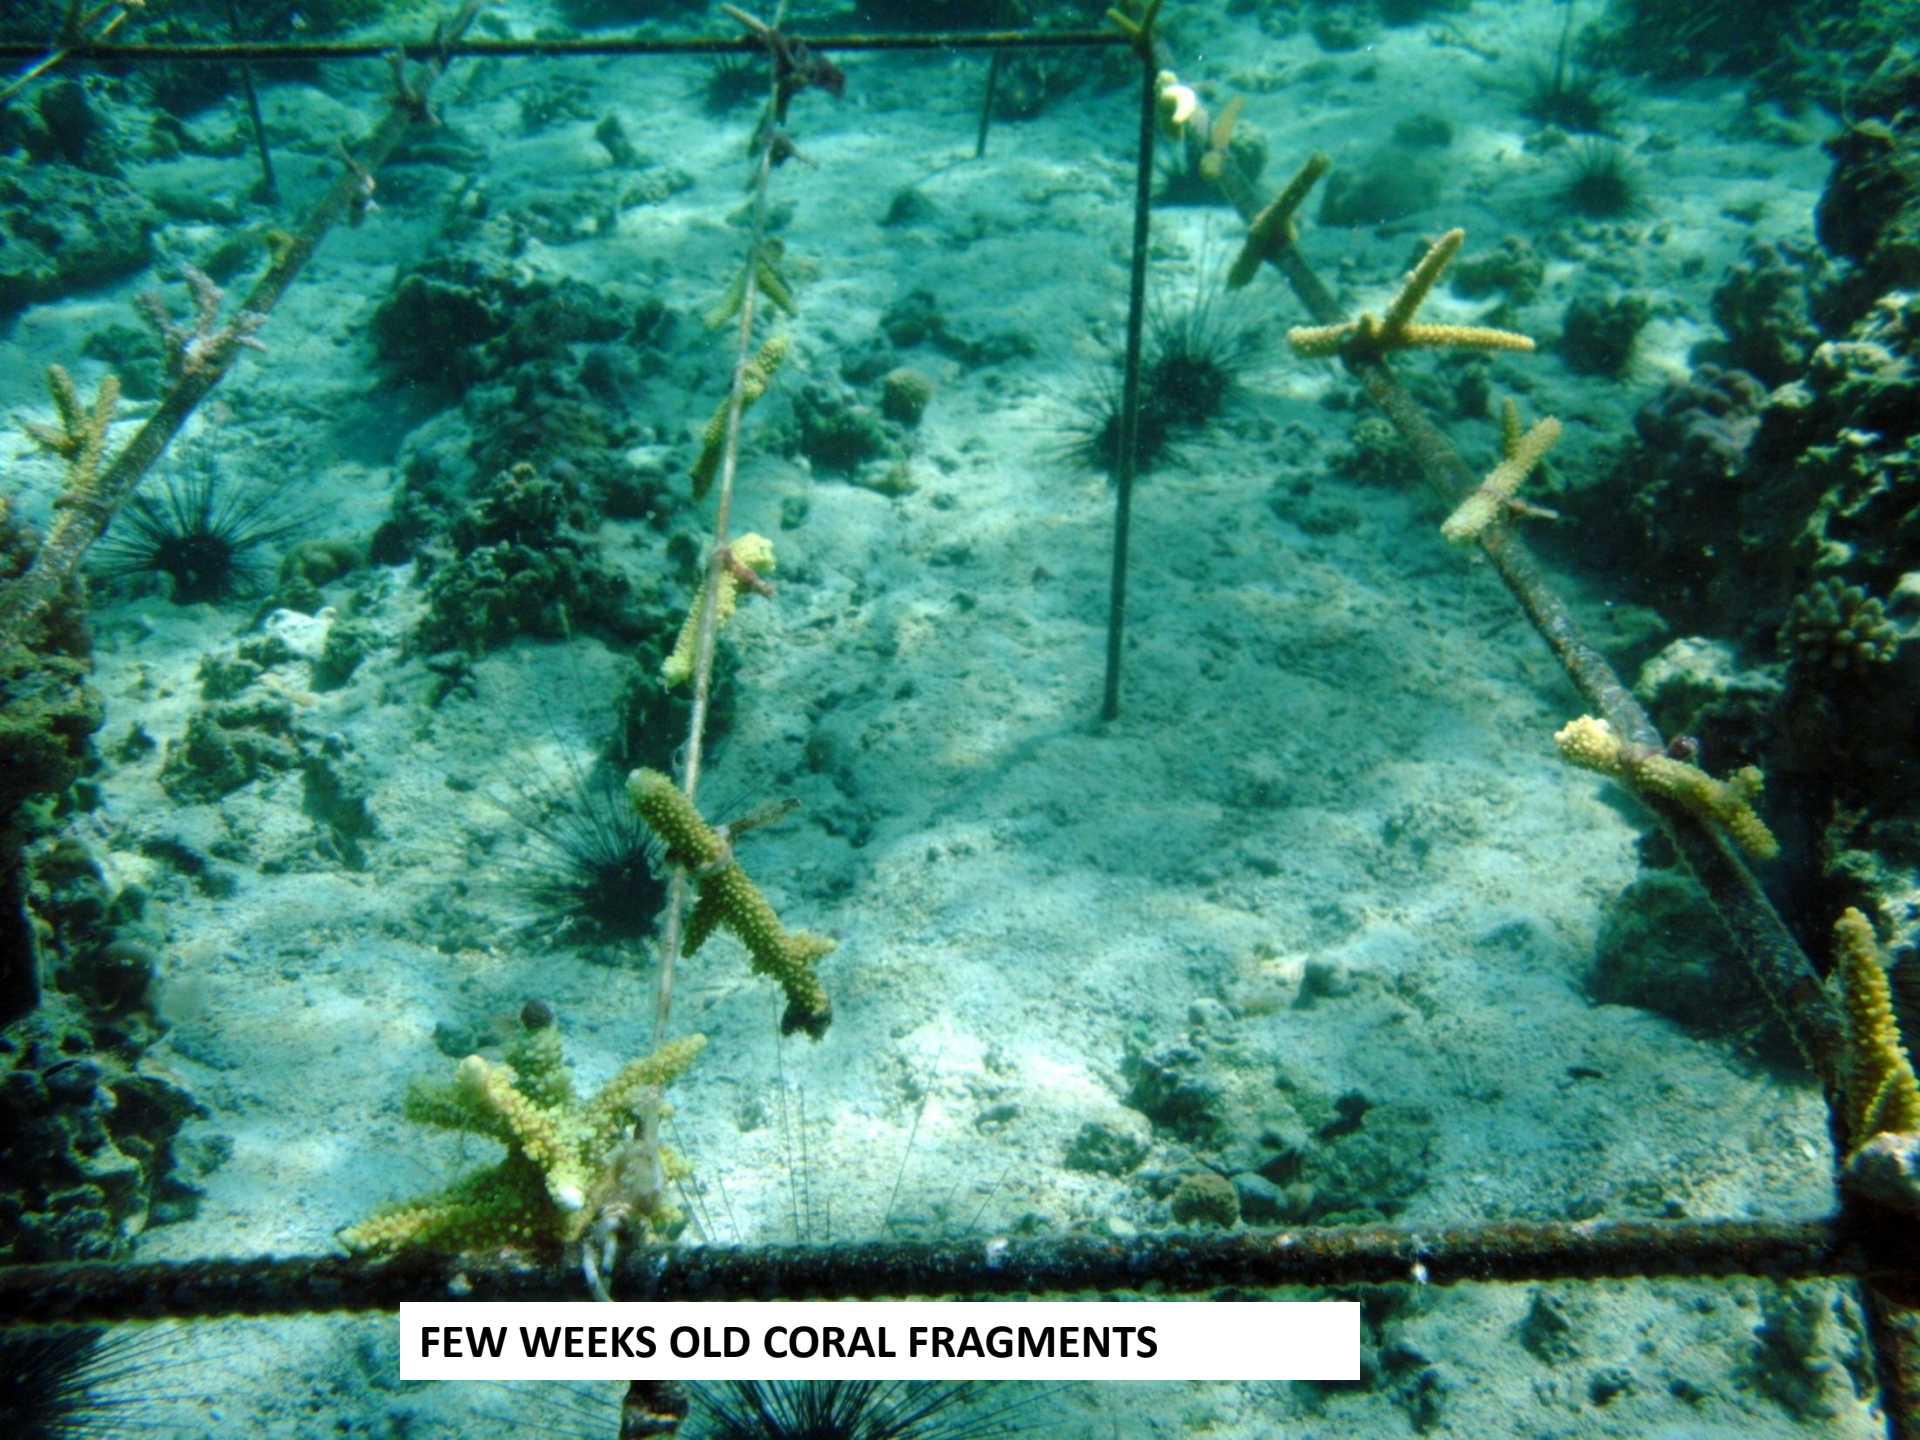
ALIVE AND GROWING FRAGMENTS

NOTE: TIE WRAPS WERE ENGULFED BY THE TISSUE OF THE GROWING CORAL

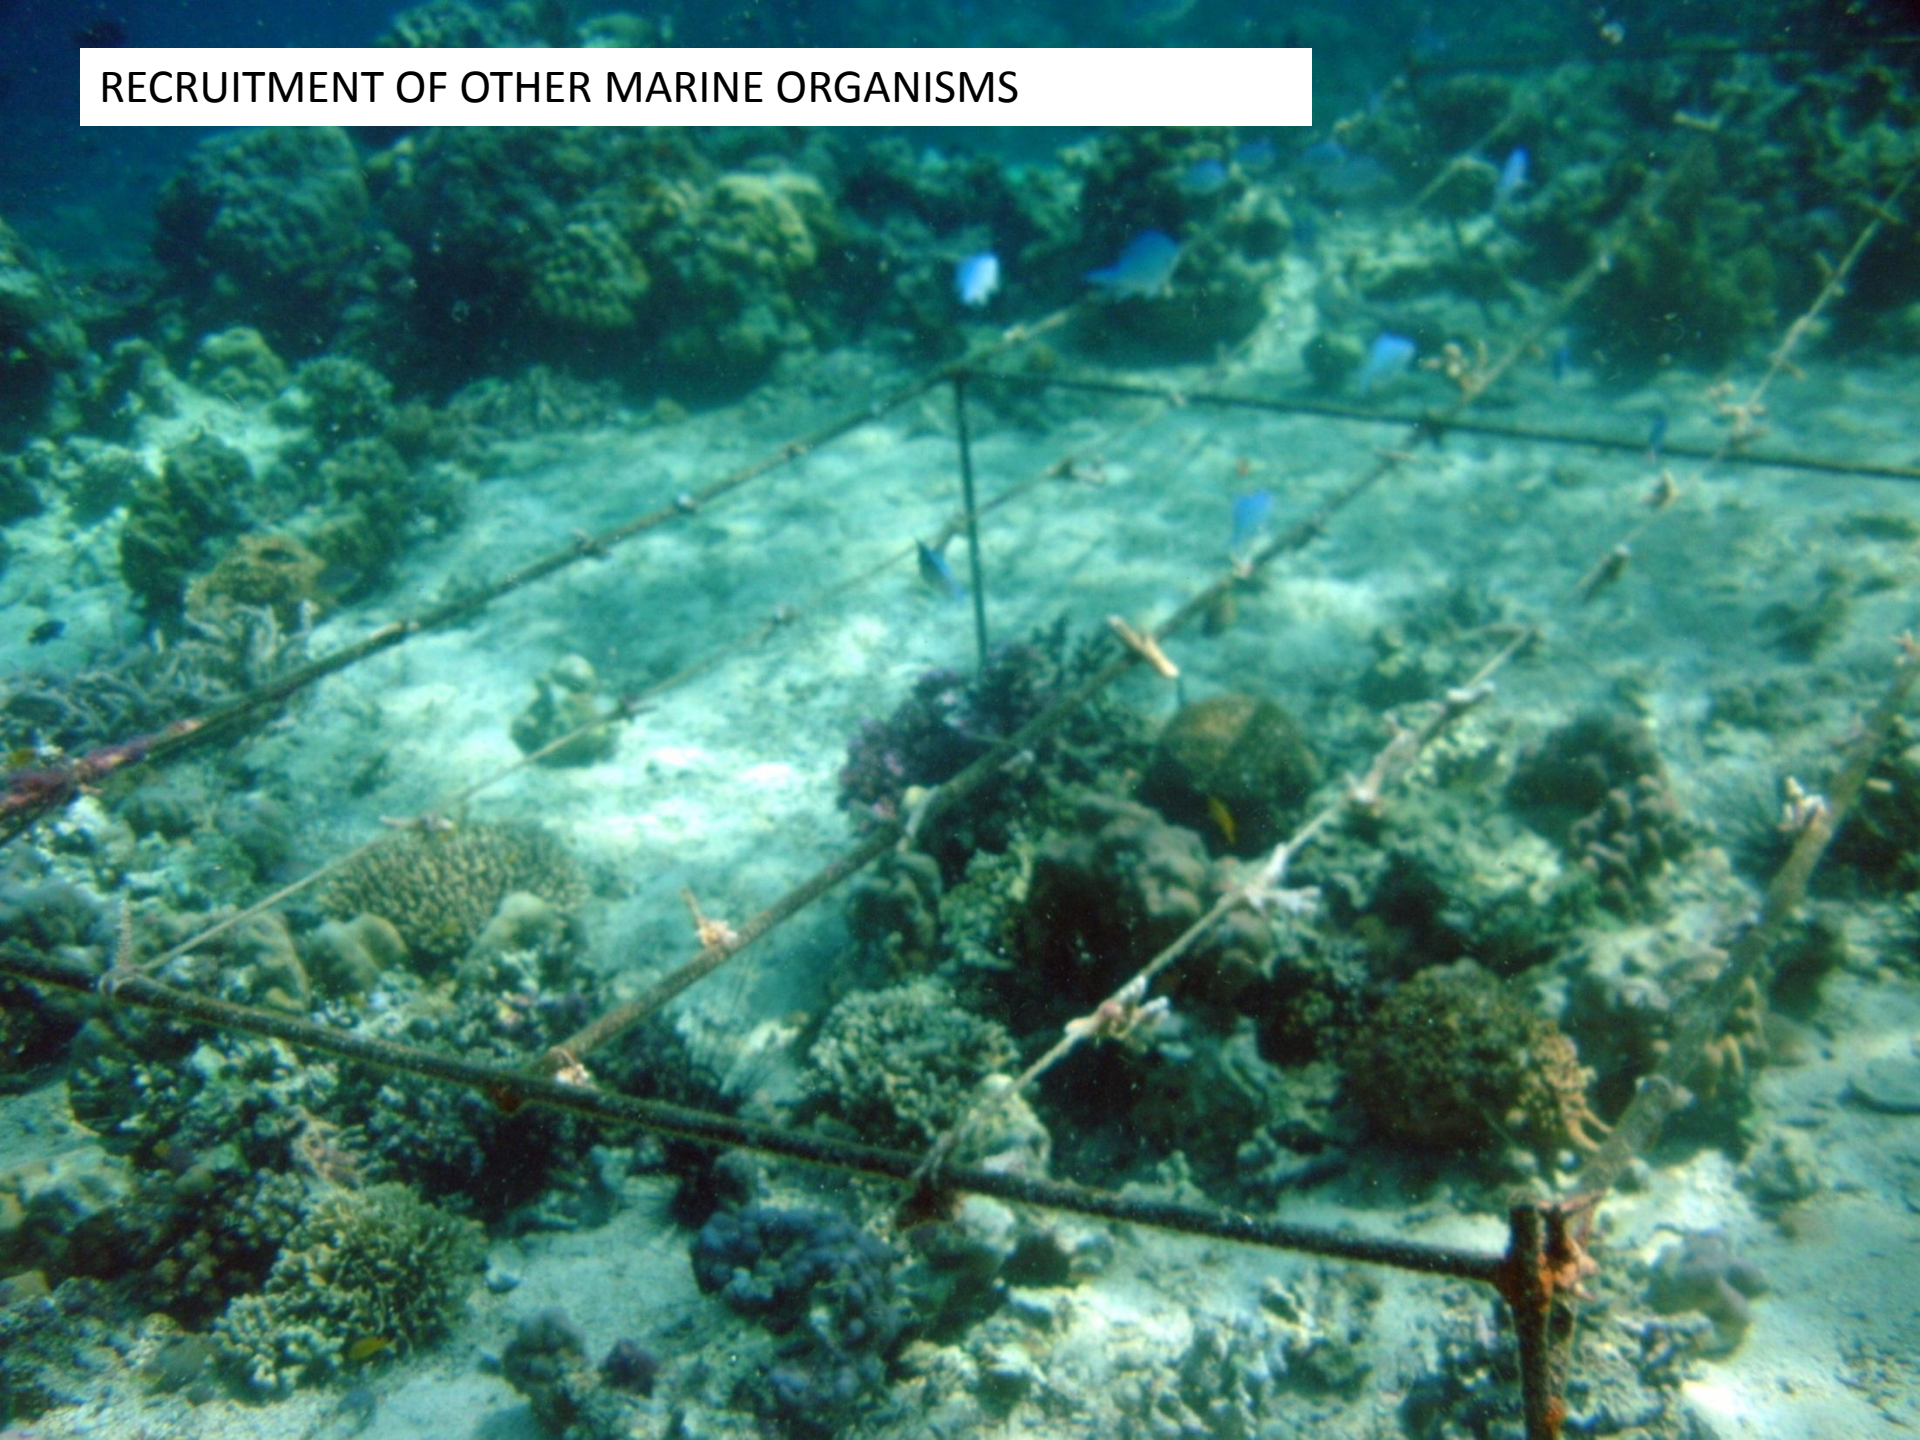
FEW WEEKS OLD CORAL FRAGMENTS

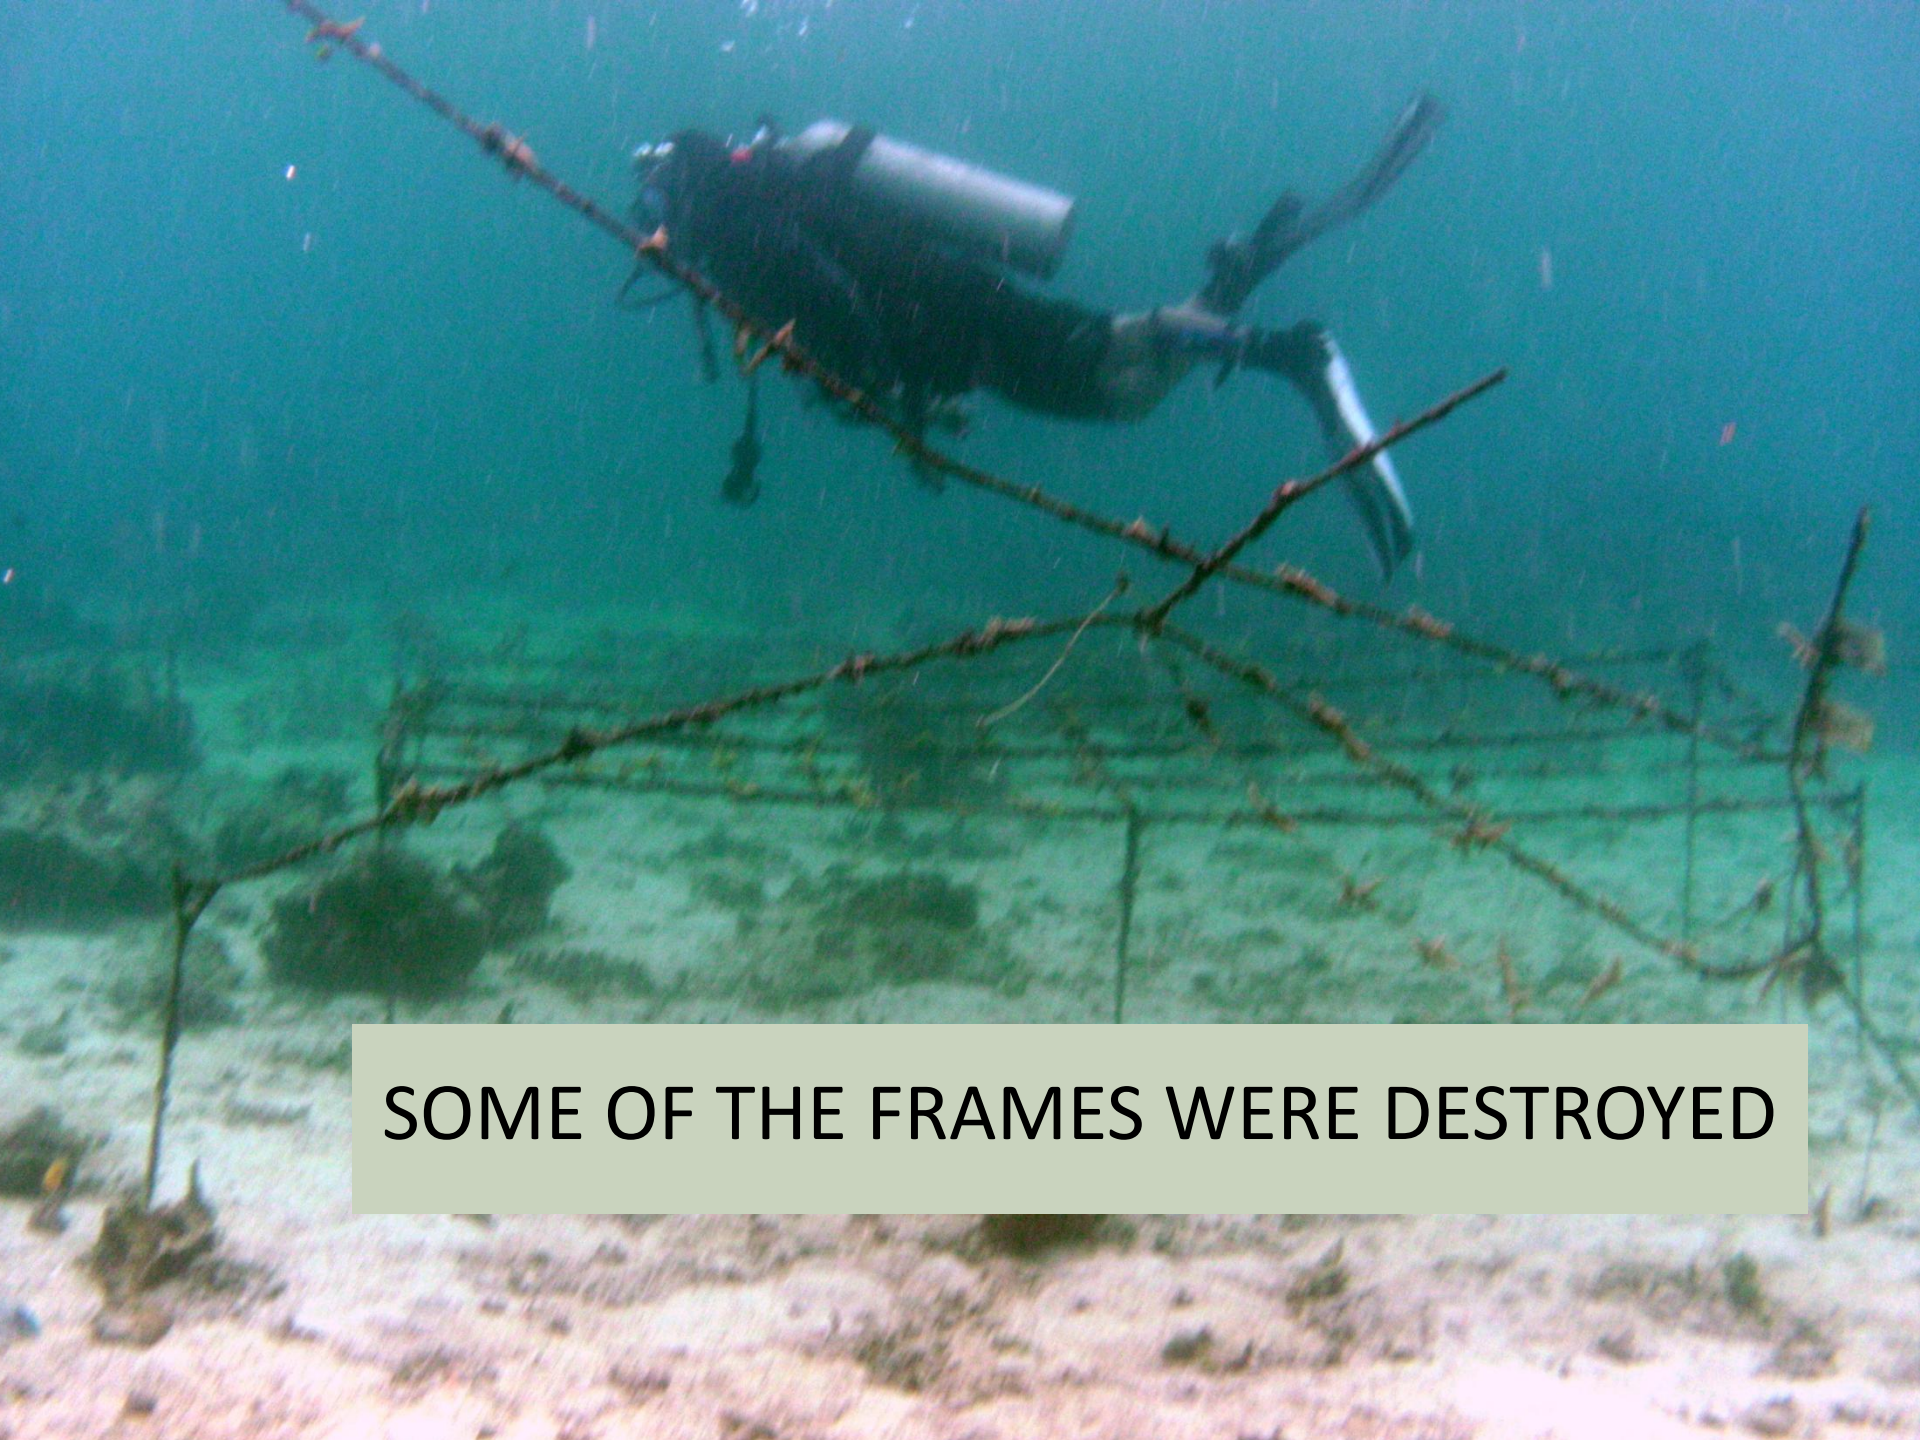
SOME OF THE FRAMES WERE DESTROYED

INVADING SEA
SQUIRTS
DOMINATED
MOST OF THE
FRAMES
WHICH LEADS
TO CORAL
DEATH

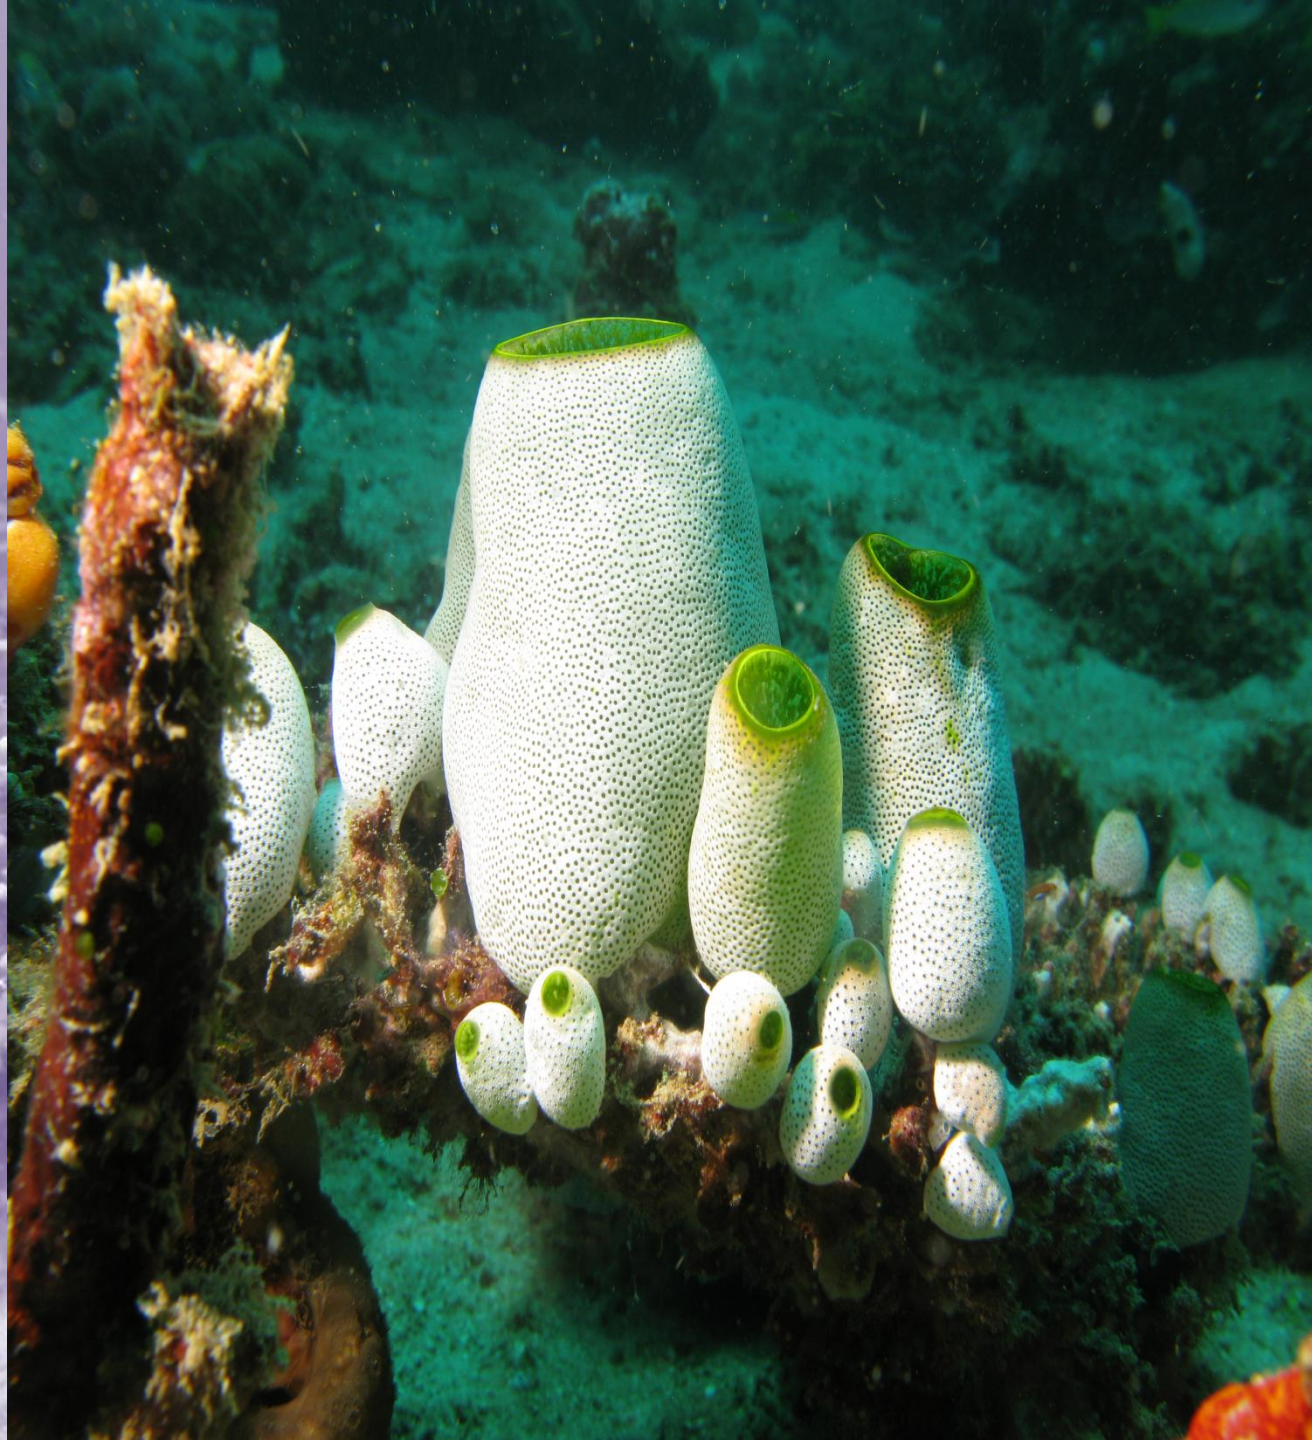
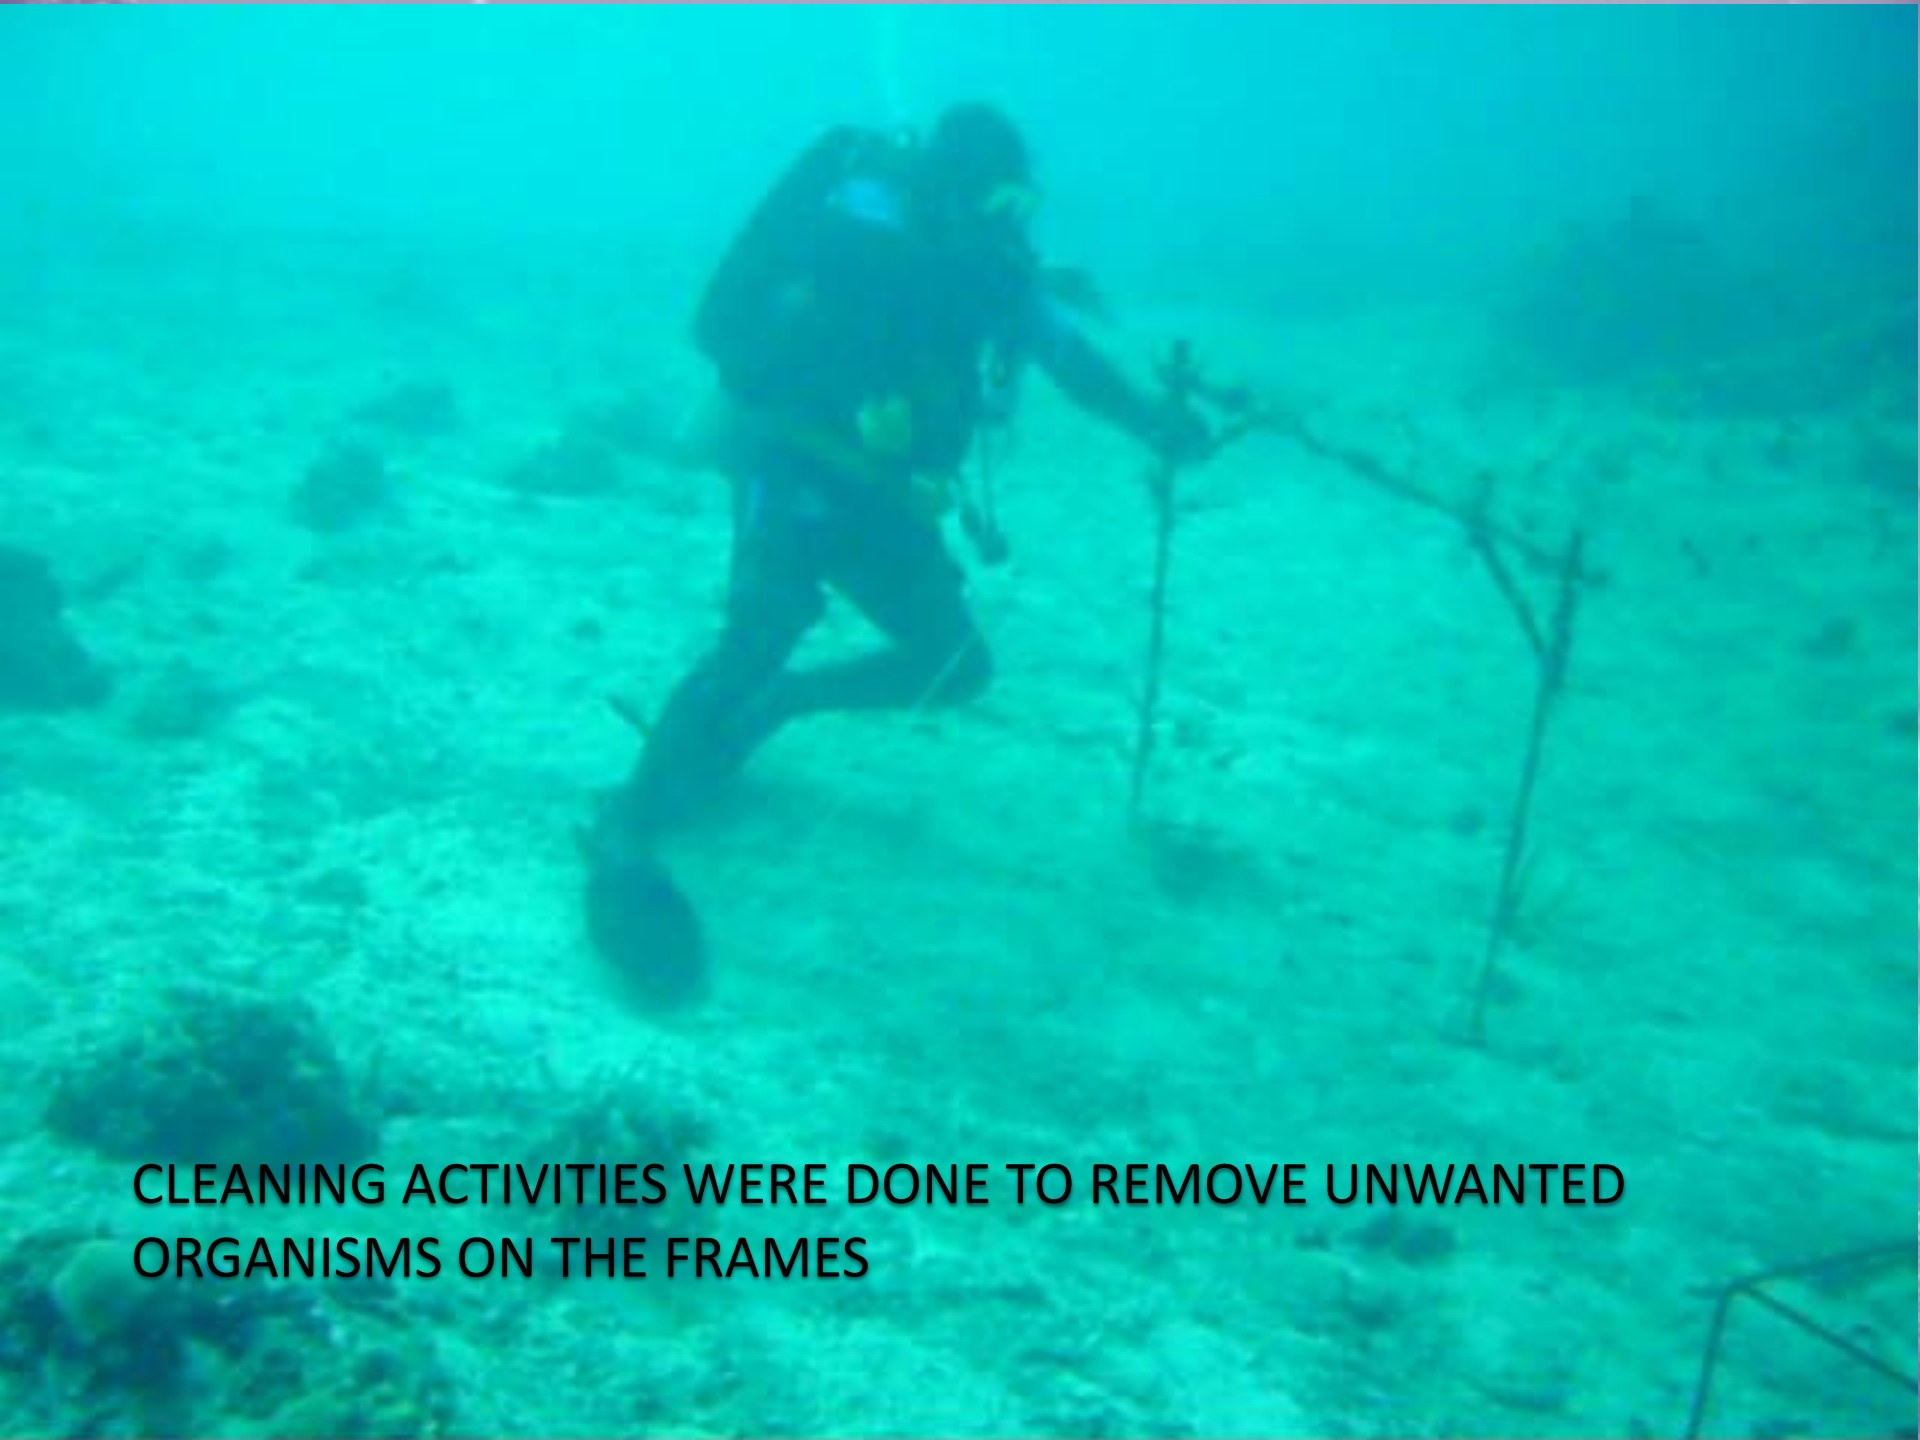
INFESTATION
OF PREDATORY
SNAIL

CLEANING ACTIVITIES WERE DONE TO REMOVE UNWANTED ORGANISMS ON THE FRAMES
