CORAL REEF REHABILITATION PROJECT

**Coastal and Marine Management Division
Protected Area, Wildlife and Coastal Zone Management Service
Department of Environment and Natural Resources
Region XI, Davao City**

PROJECT DESCRIPTION

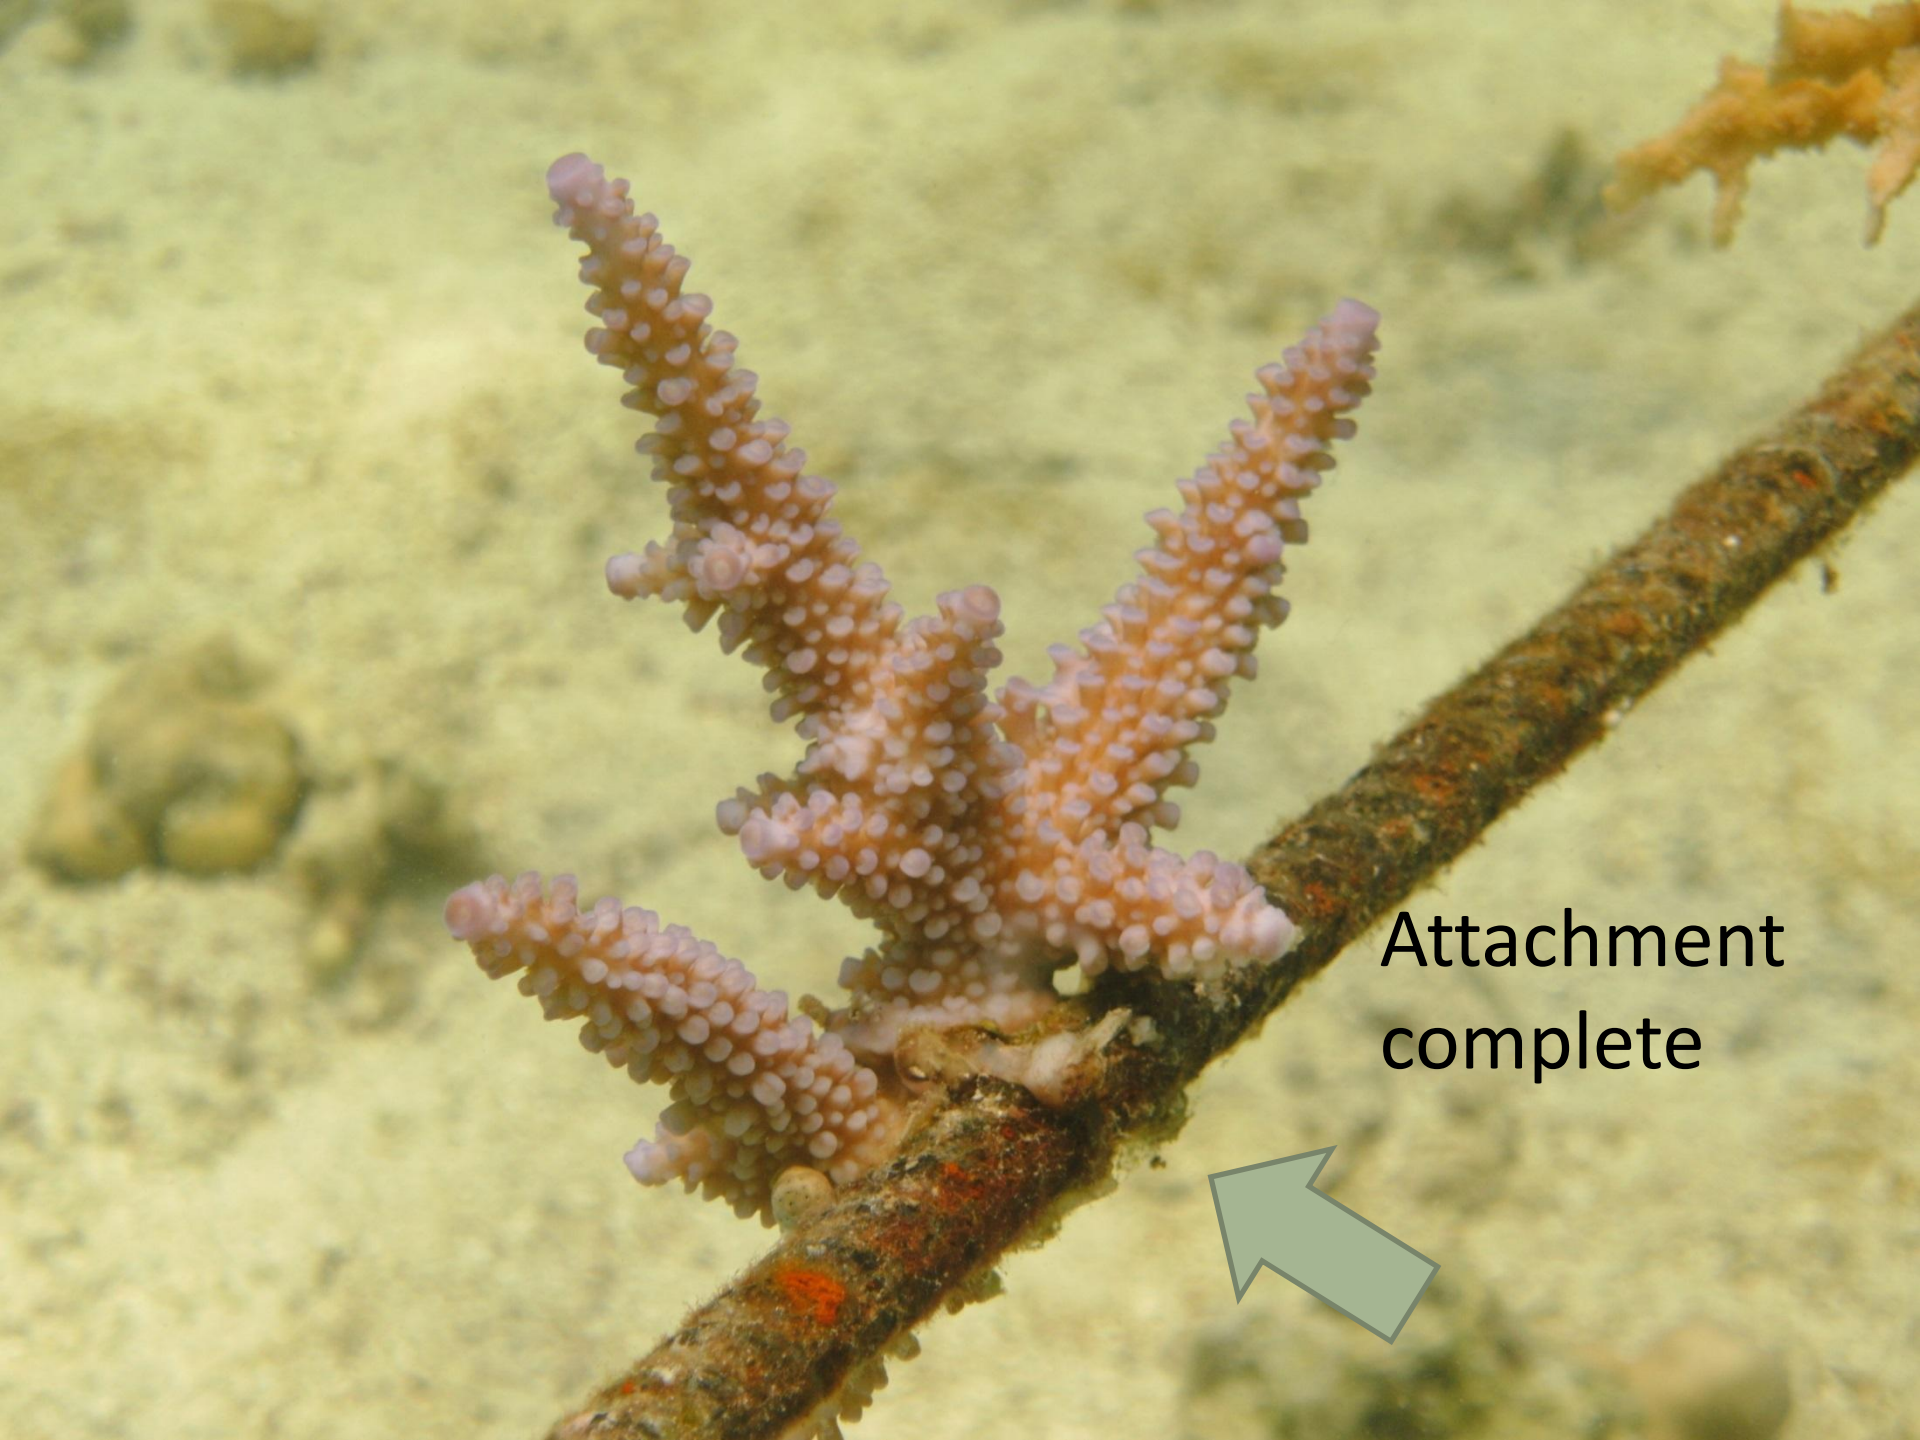
Some of the fragments grew too much so that ends of different fragments meet

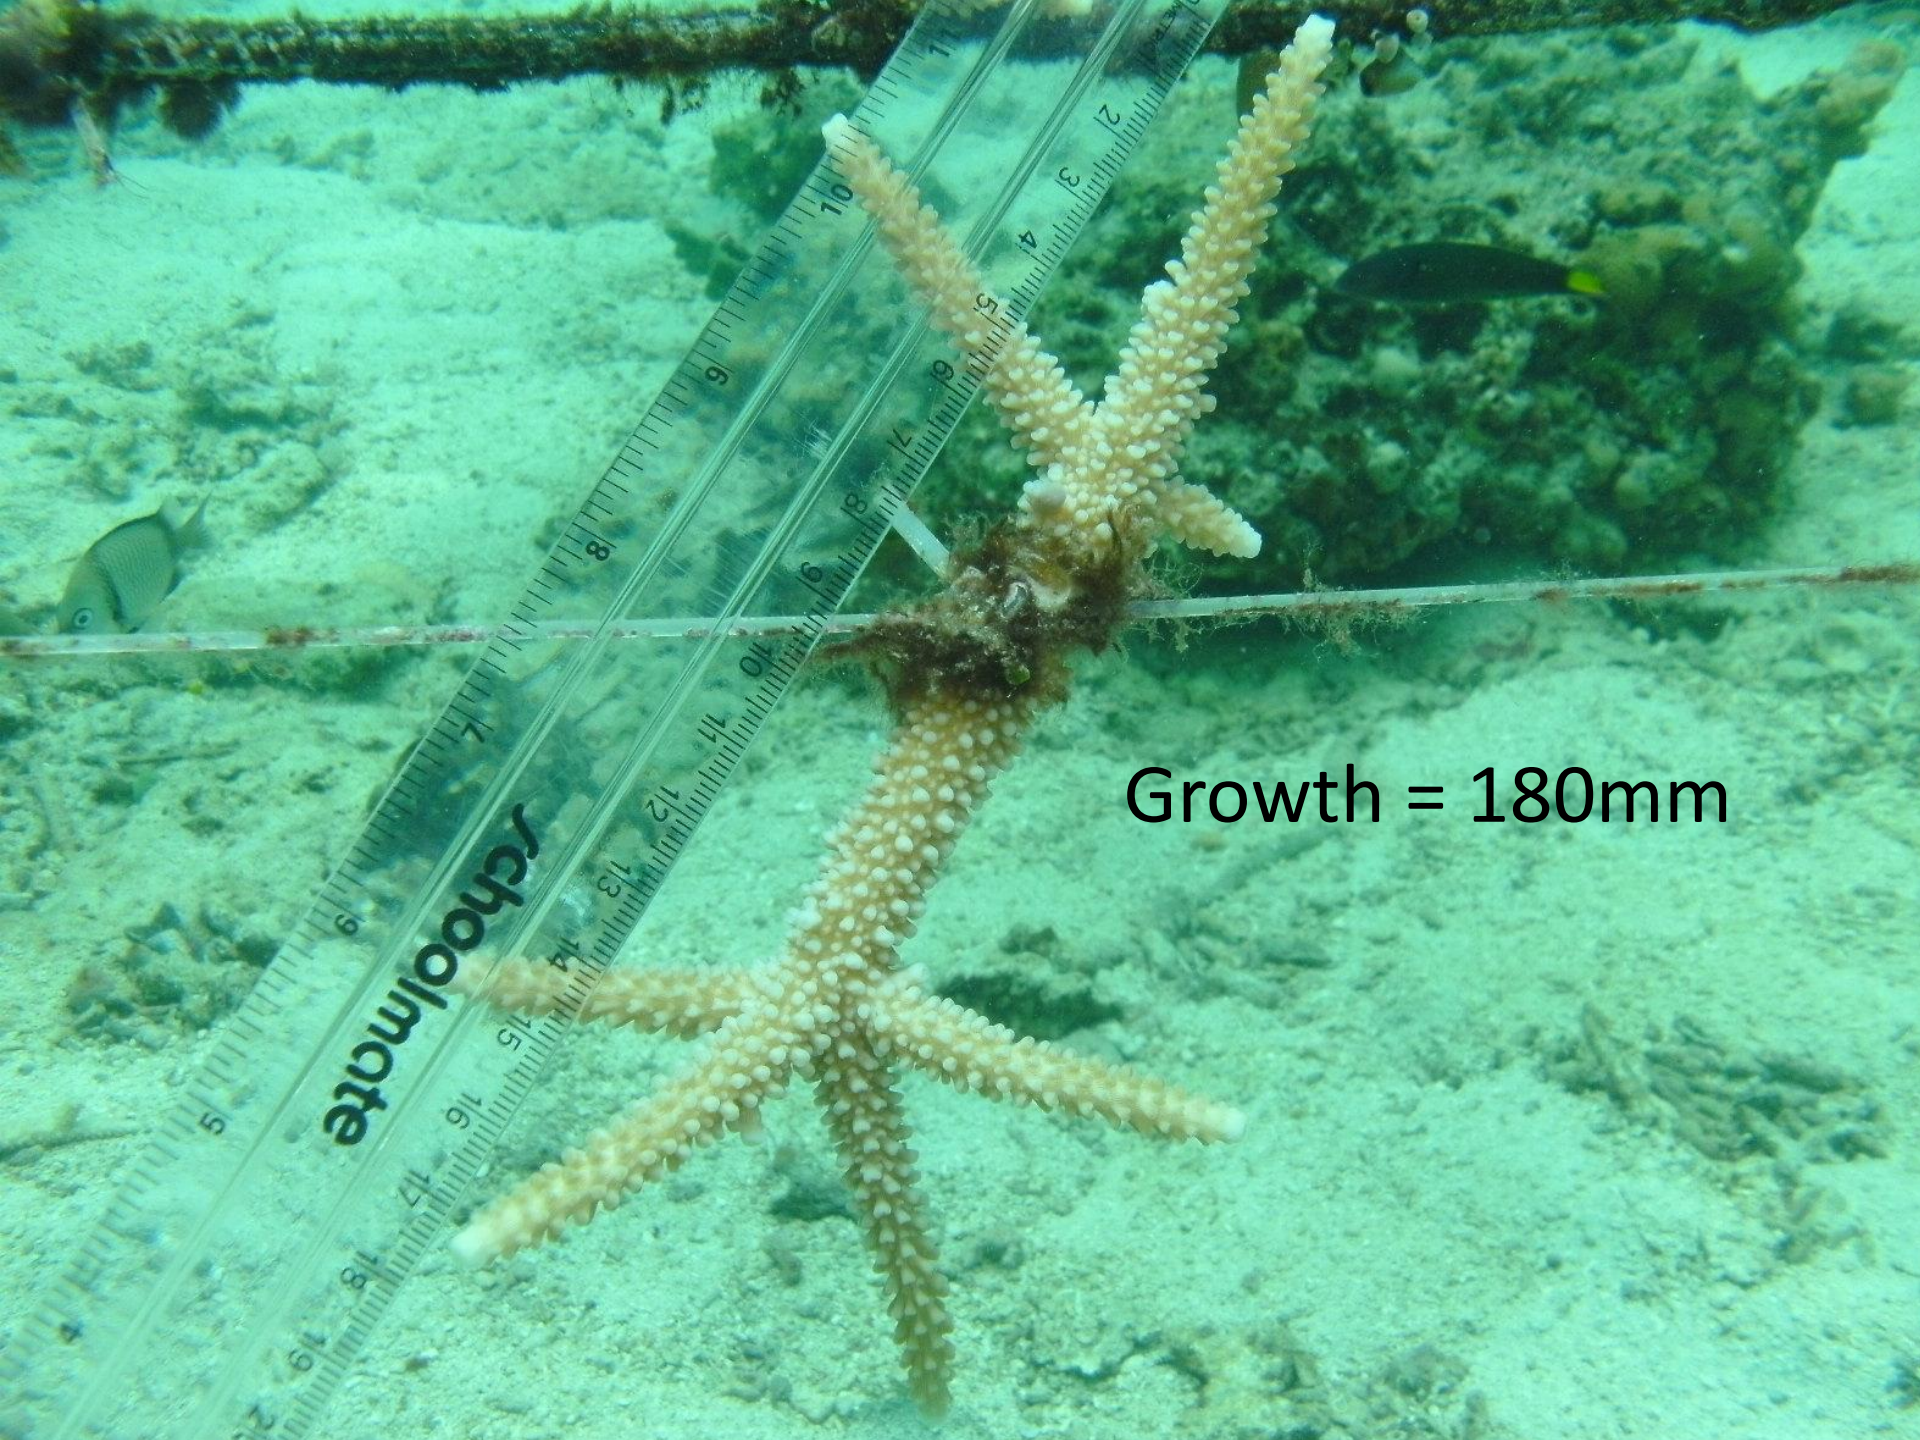
Growth = 180mm

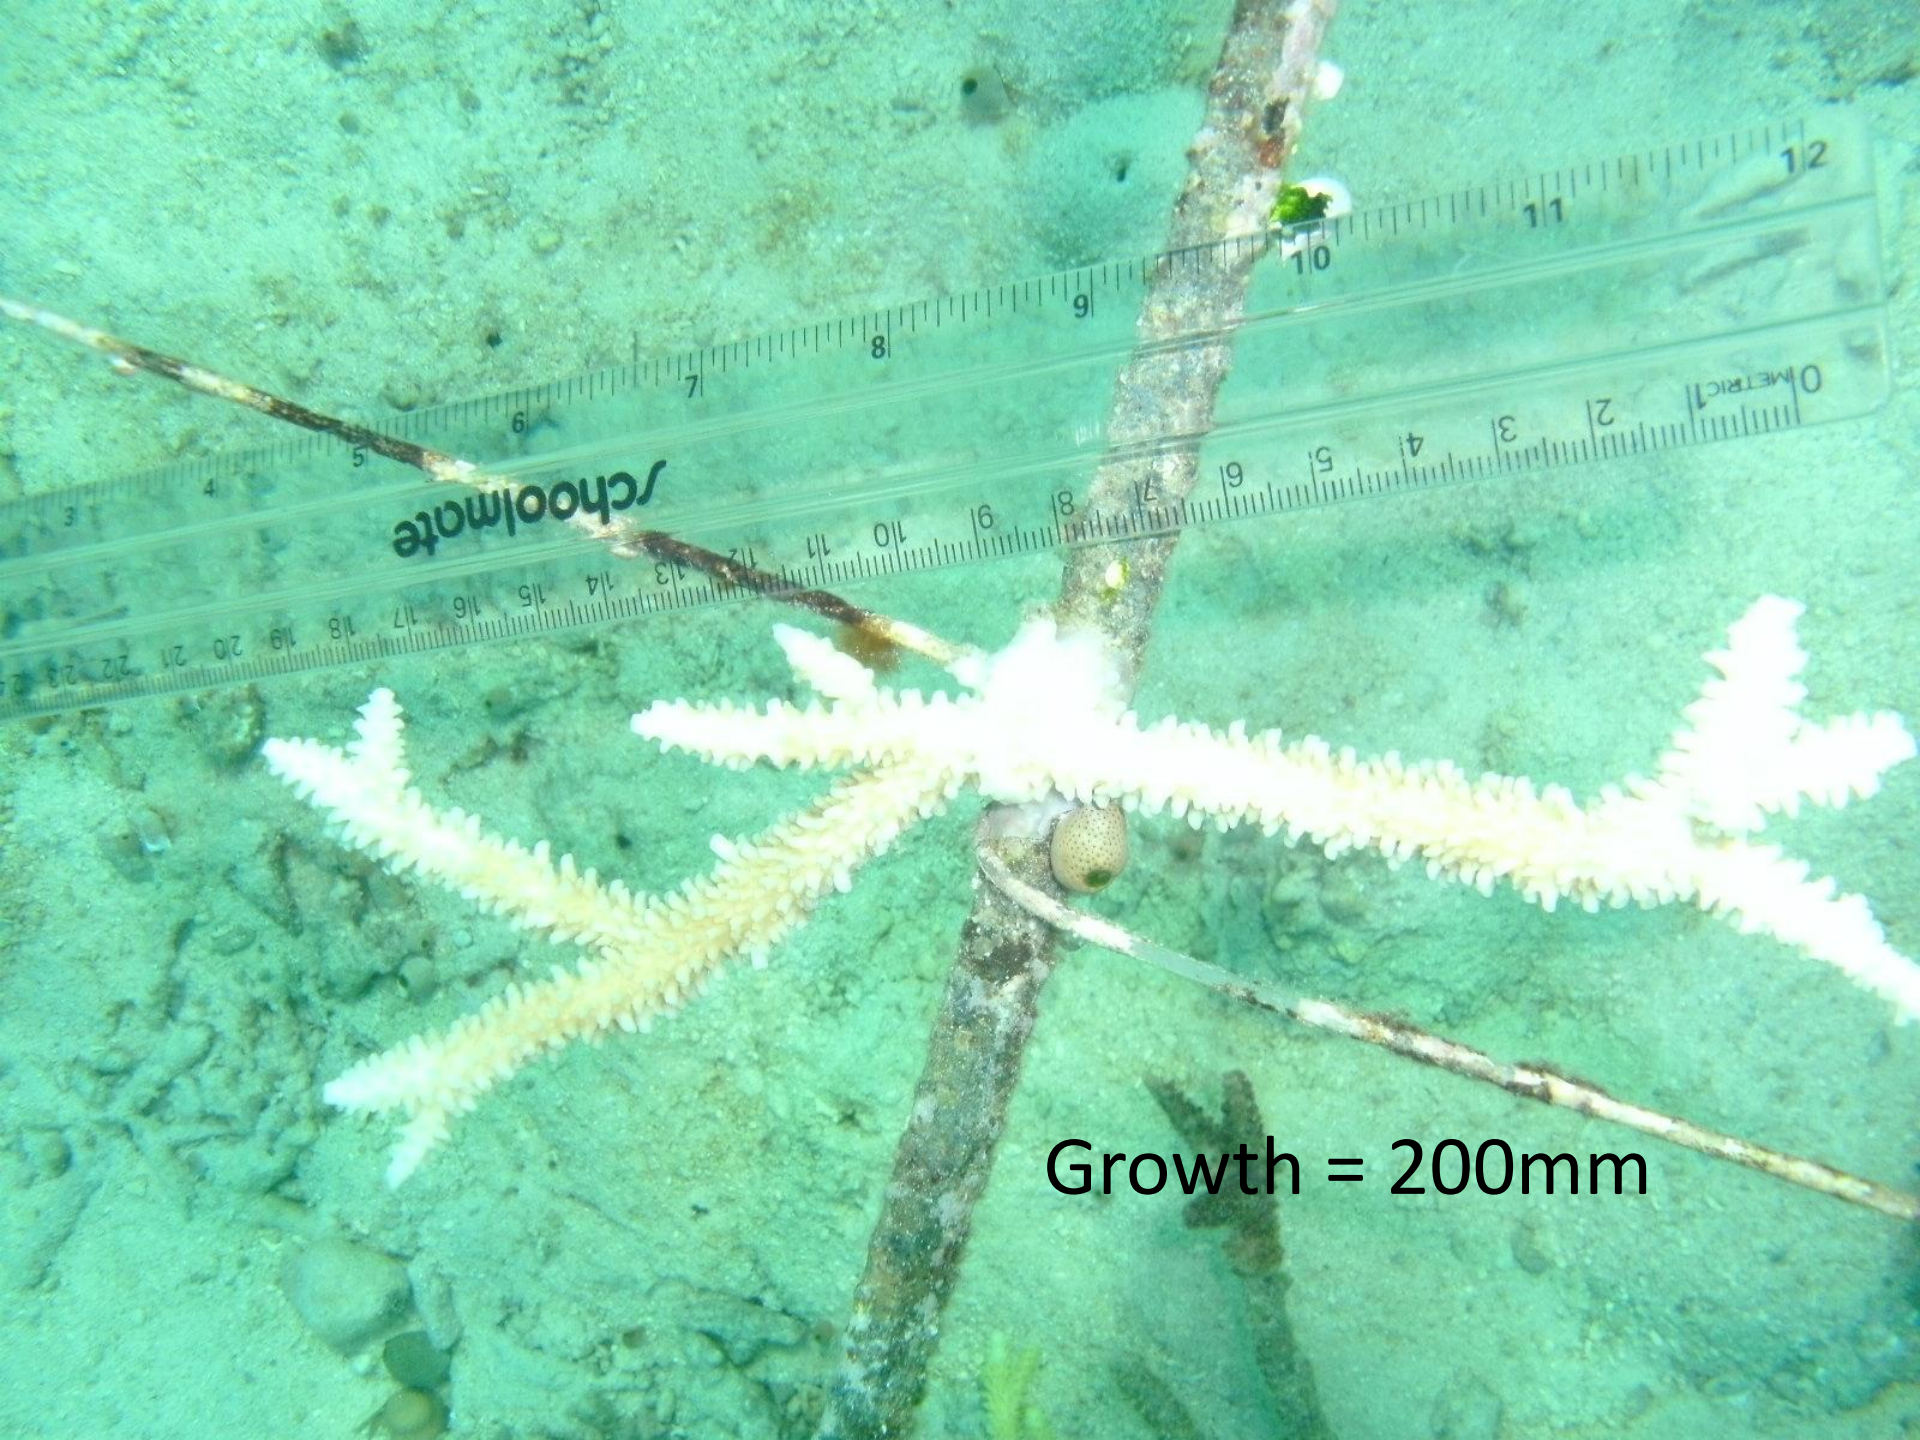
Growth = 200mm

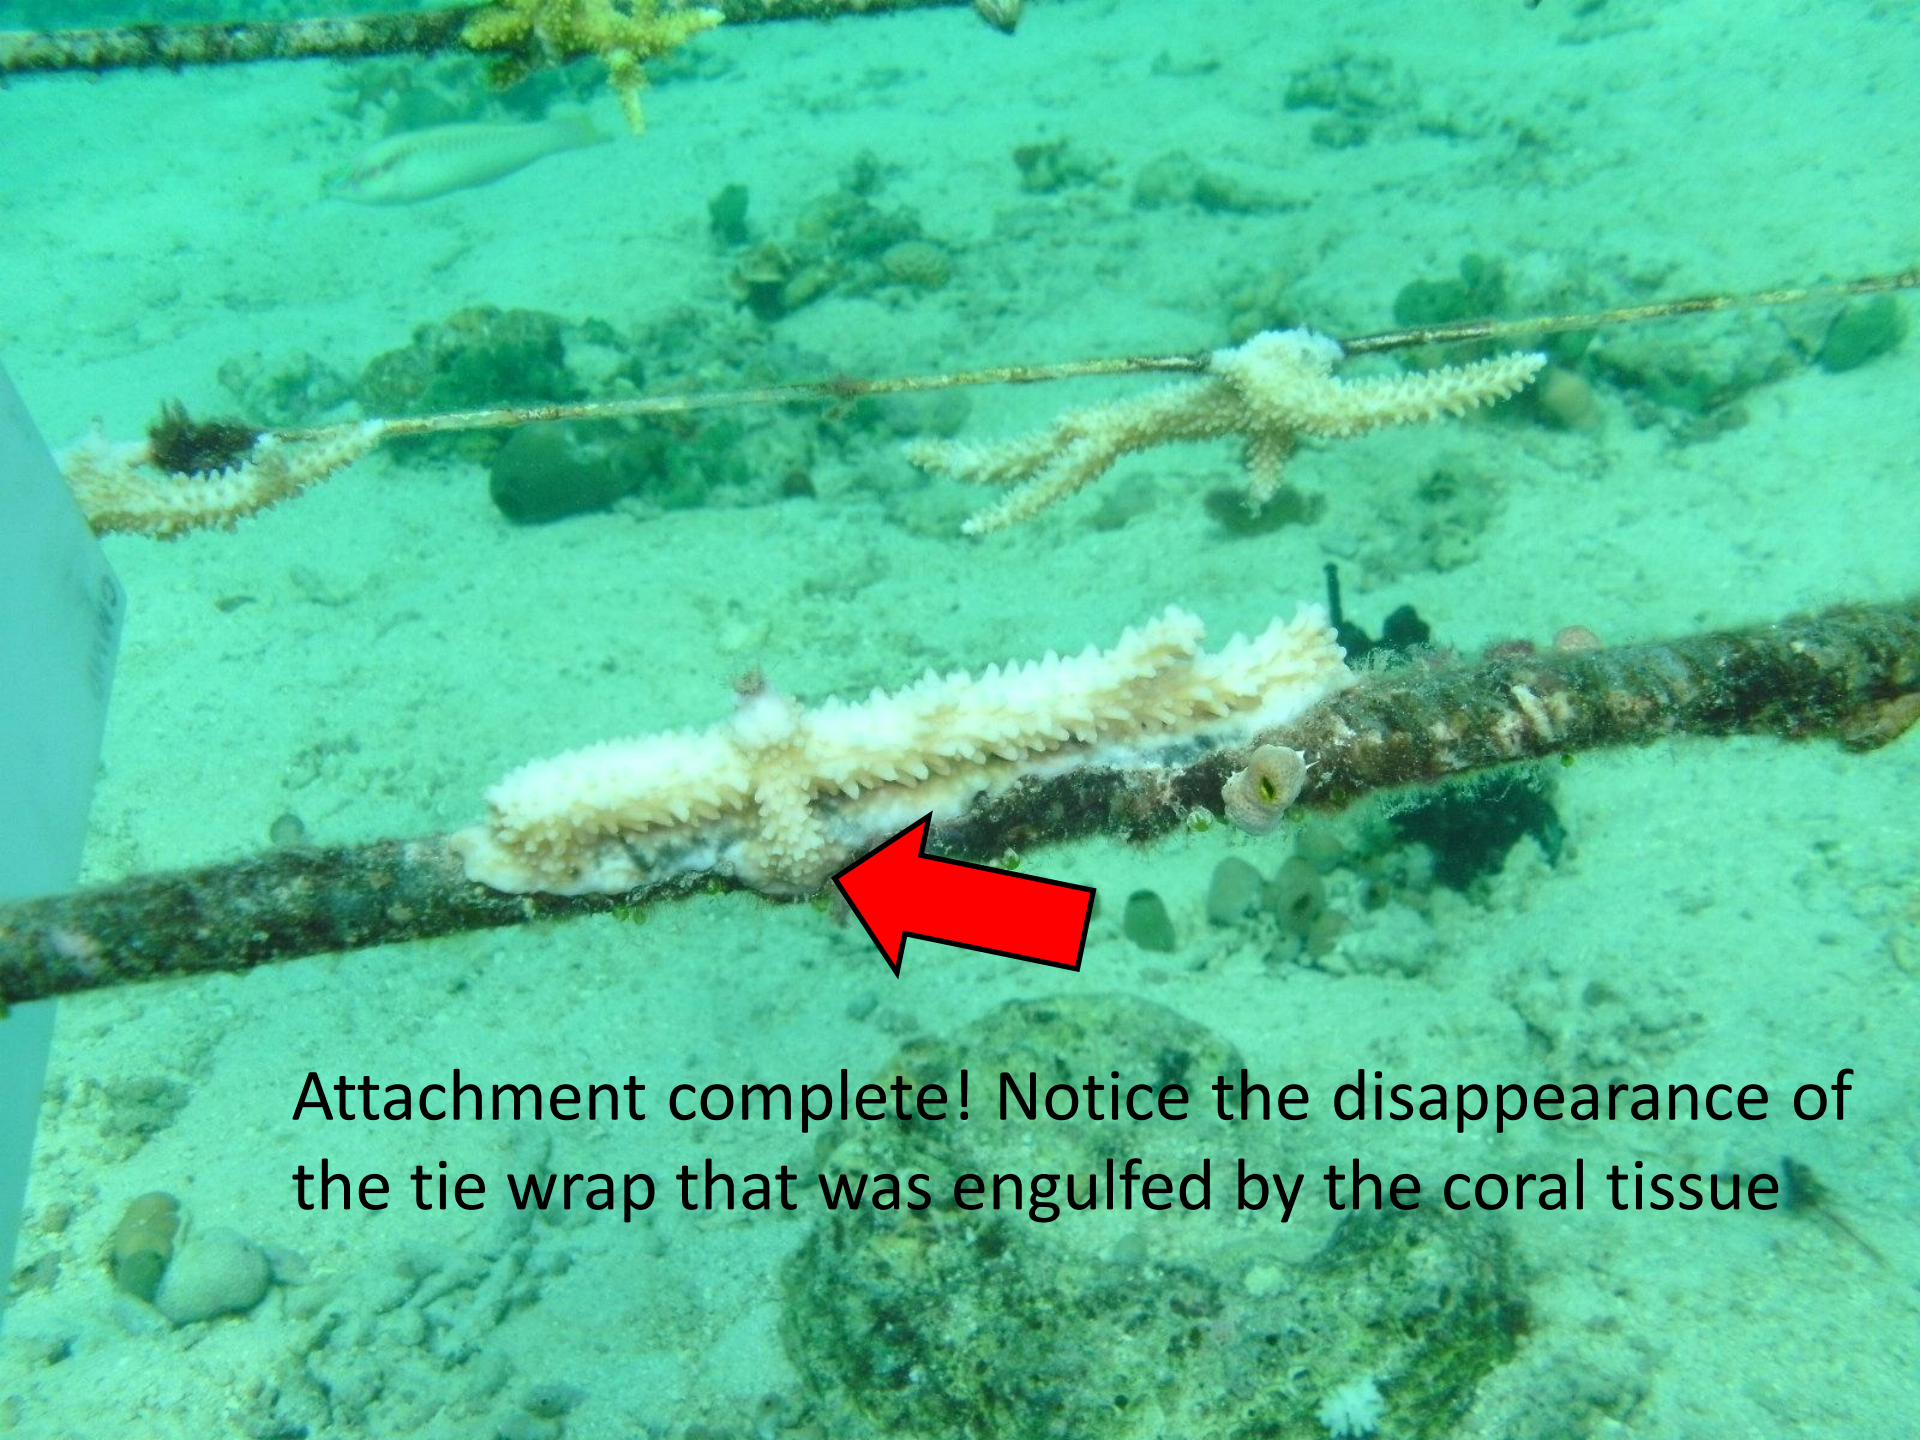
Attachment complete! Notice the disappearance of the tie wrap that was engulfed by the coral tissue

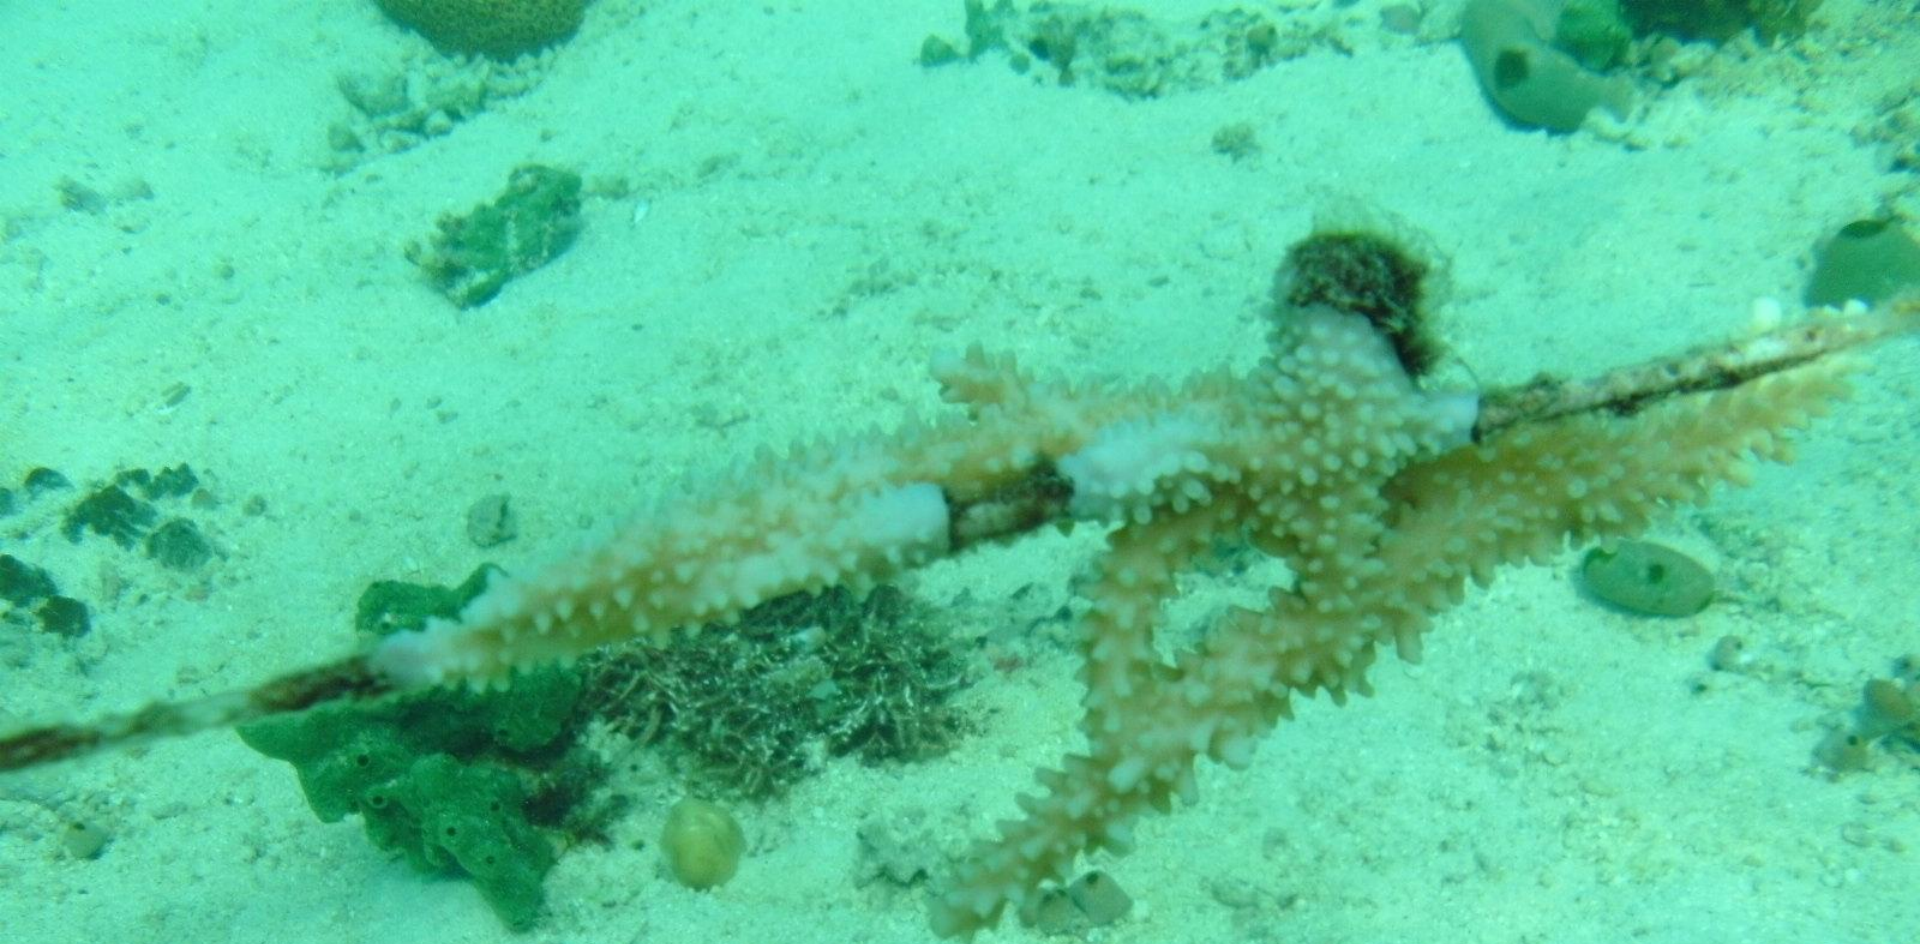
A branching coral making the nylon line its foundation and spread its tissue through it to extend colony

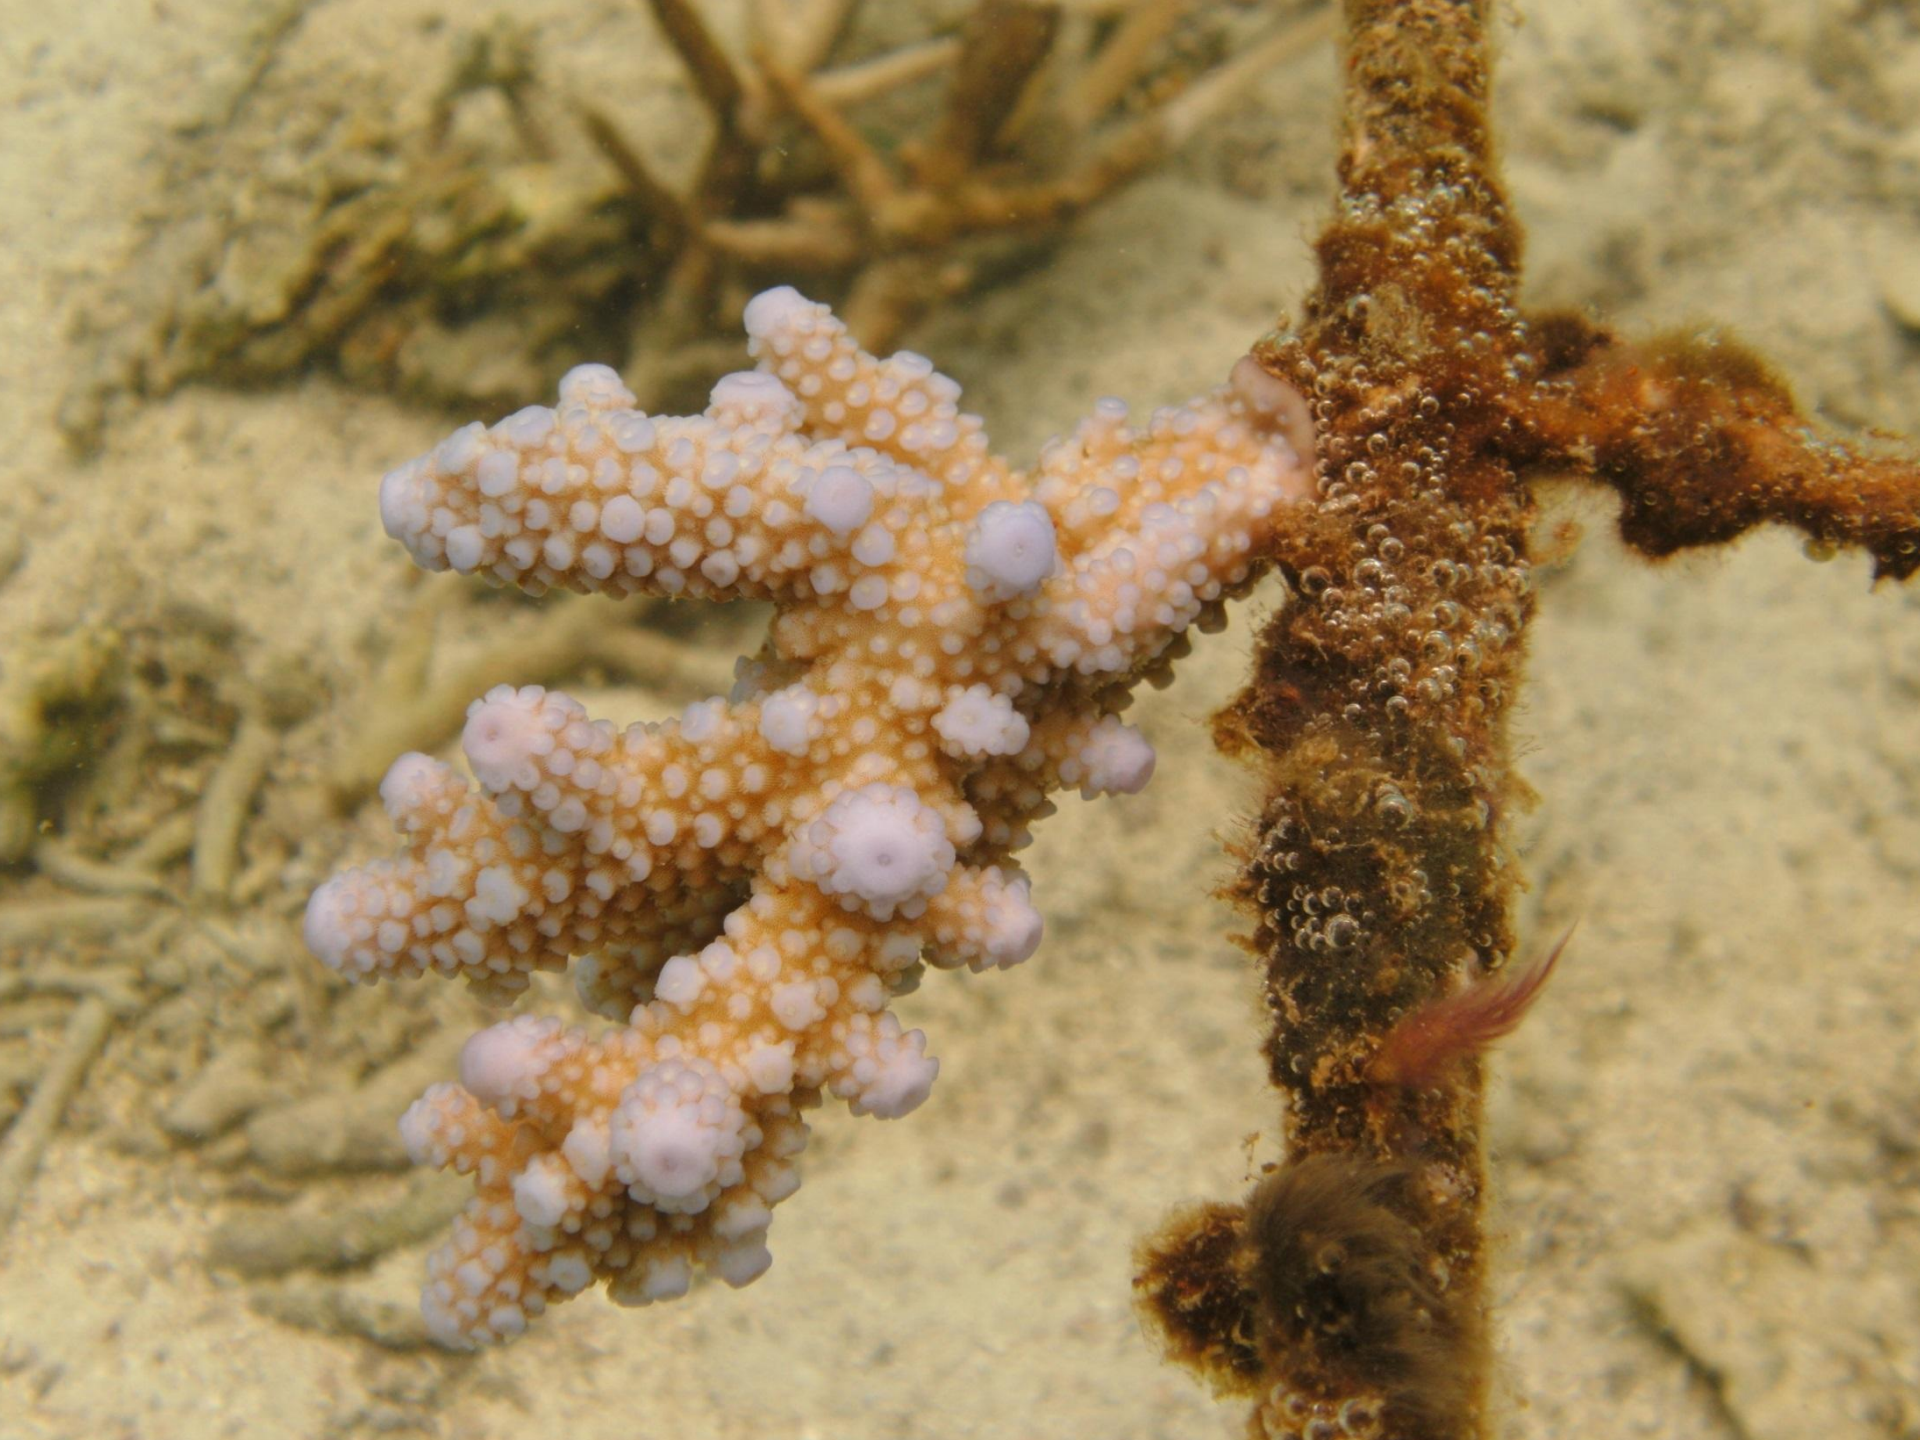
In spite the
competition,
this coral
colony has
managed to
grow amidst
thick algal
growth

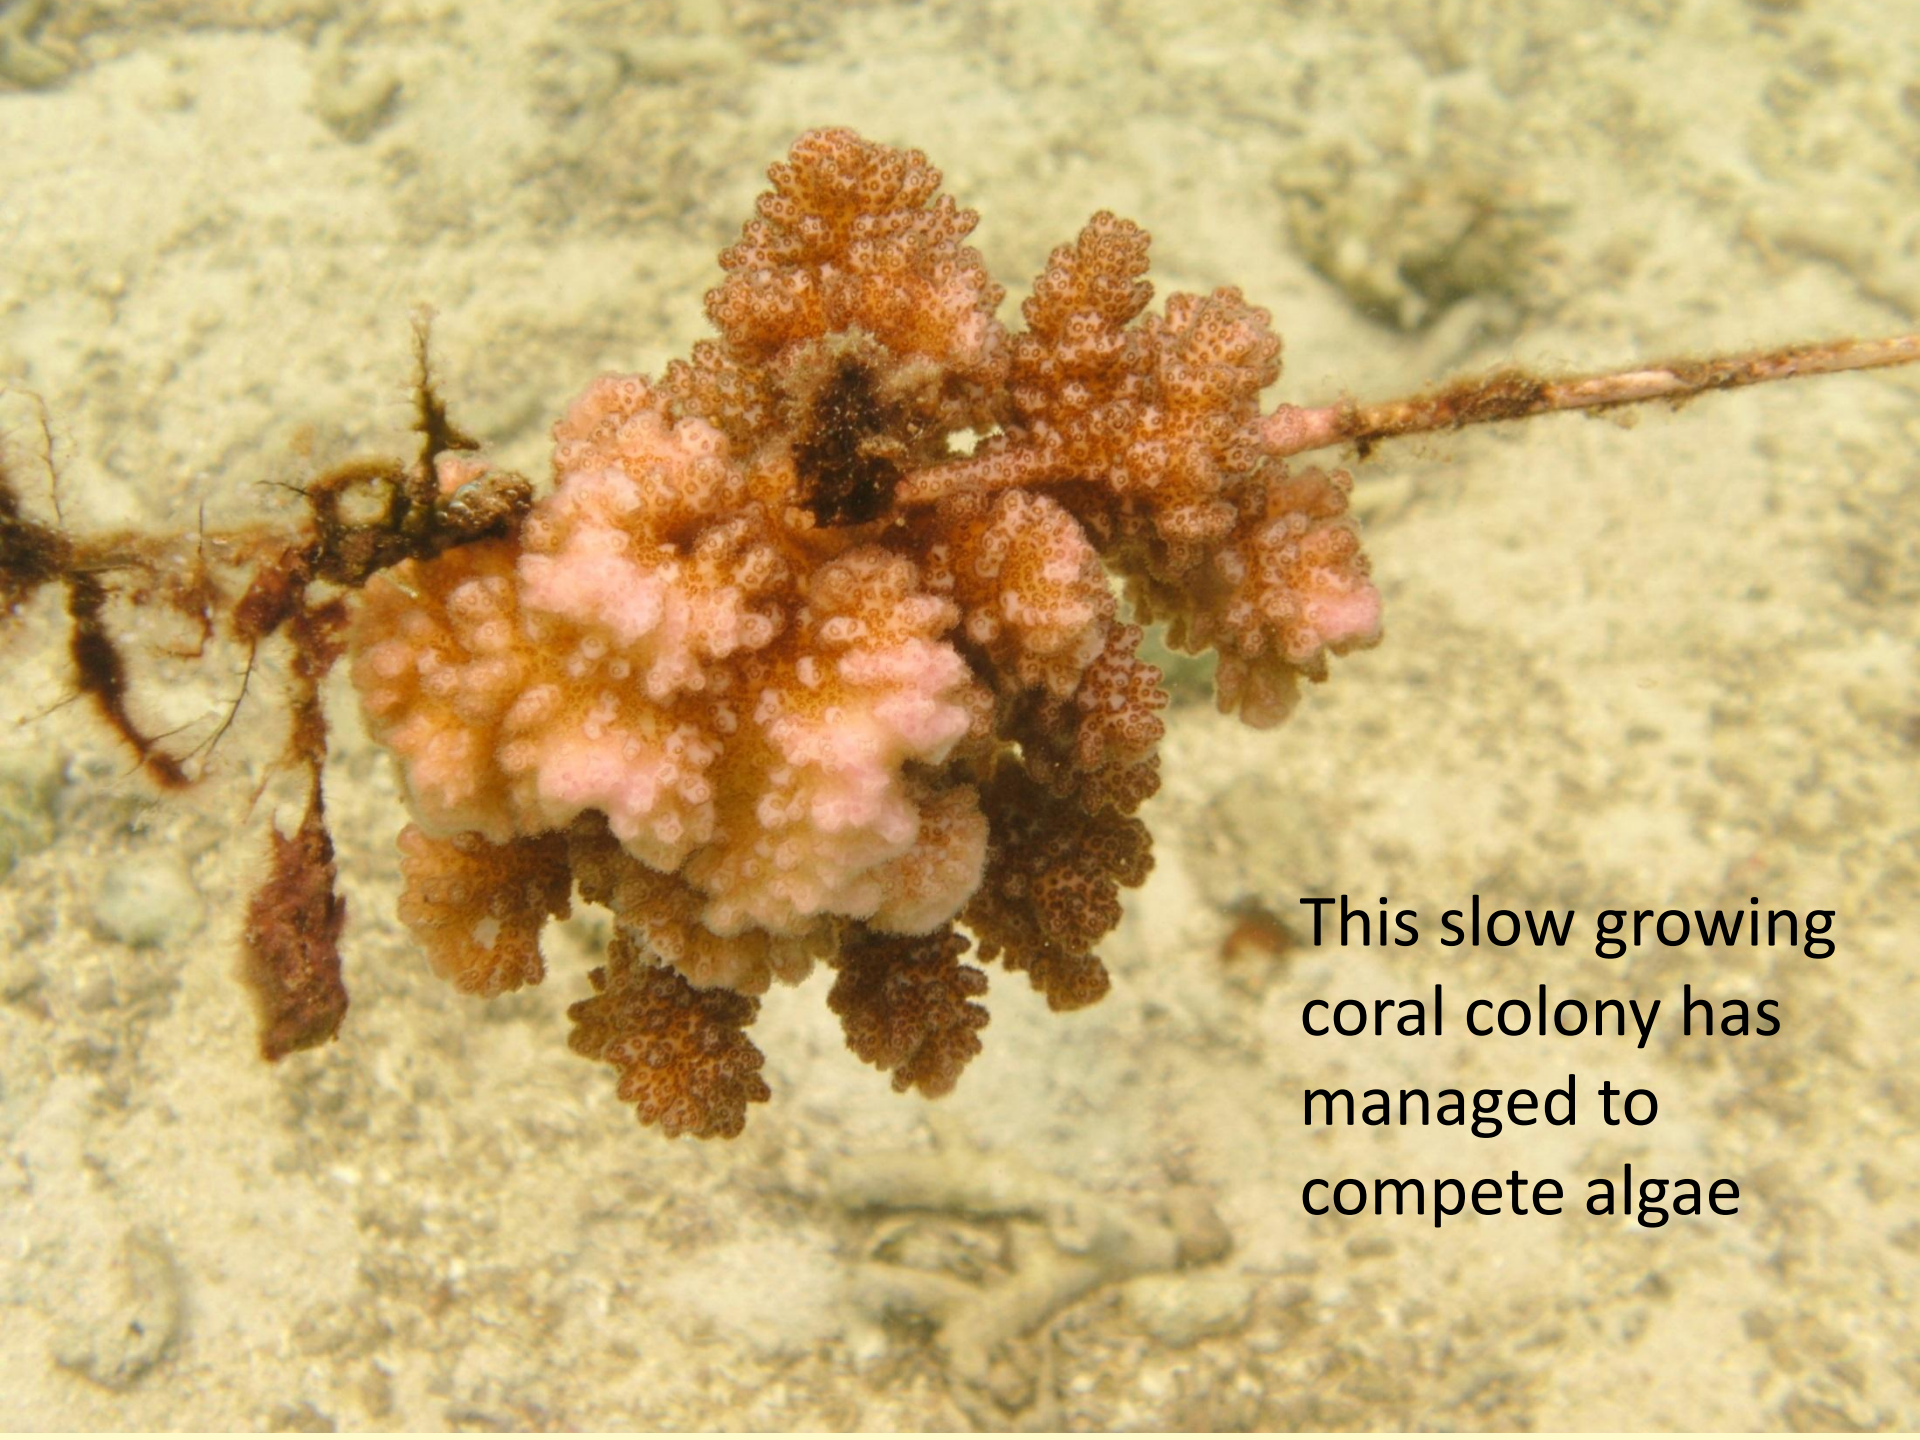
This slow growing
coral colony has
managed to
compete algae

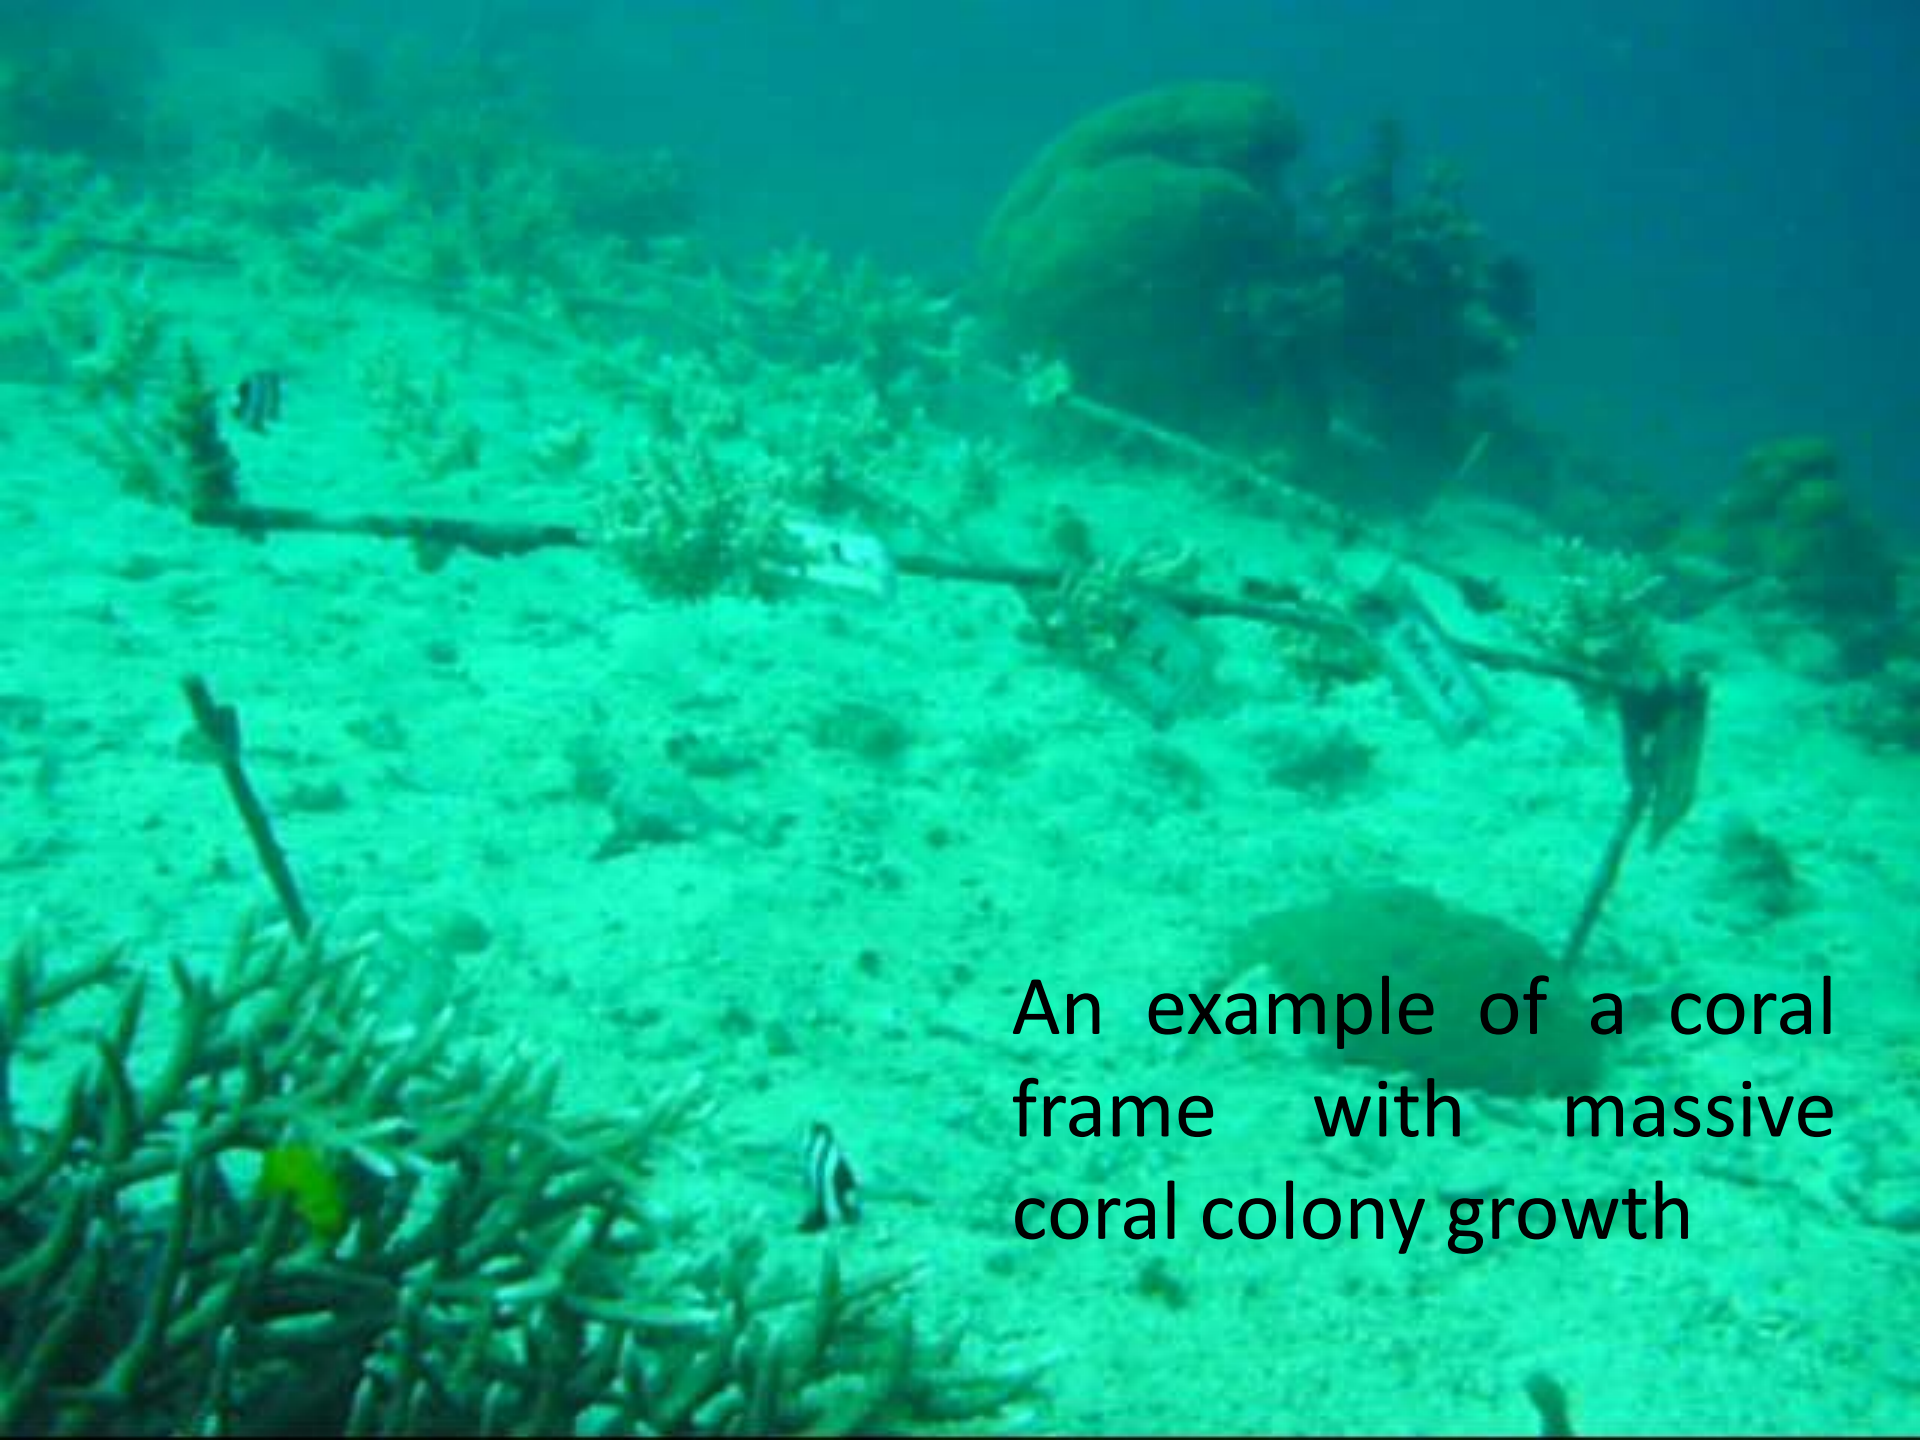
An example of a coral
frame with massive
coral colony growth
