CORAL REEF REHABILITATION PROJECT

**Coastal and Marine Management Division
Protected Area, Wildlife and Coastal Zone Management Service
Department of Environment and Natural Resources
Region XI, Davao City**

PROJECT DESCRIPTION

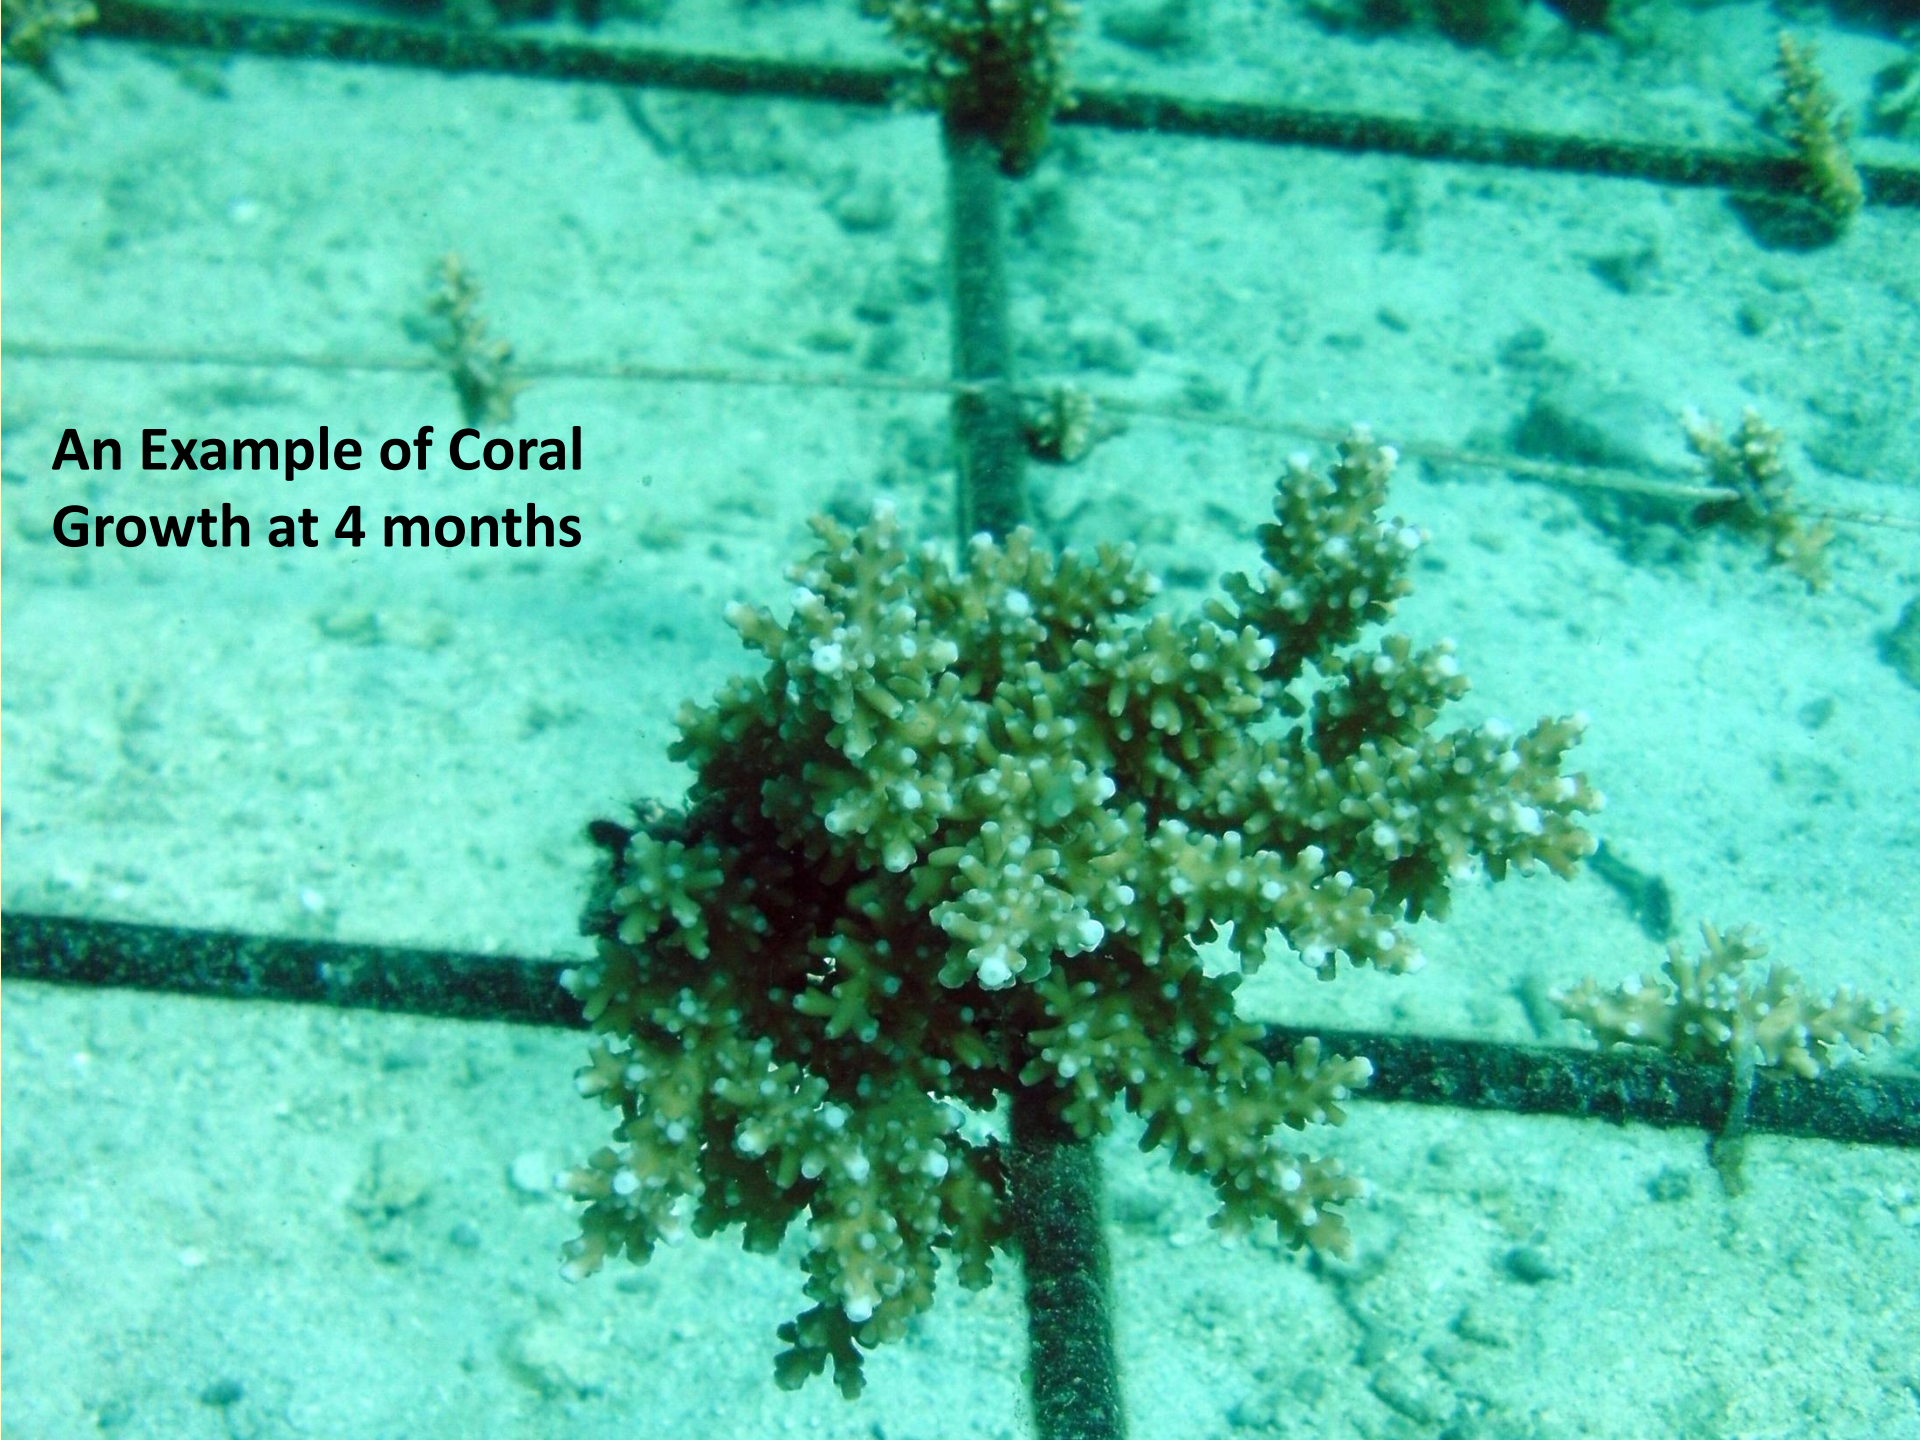
**Coral Growth on the
8th month**
